Access Compliance Report

Public Rights-of-Way

(Curb Ramps)

Intersection ID: 31771	Main Street: STARNES RANDALL RD	Cross Street: PINYON PINE LN	Location: N
ADA ID: 36B45BFB47F8	Ramp Type: Perp	Initial Pass/Fail: Fail	Overall Compliance: No
Severity Score: 33.75			
Codes/Mitigation Info/Possible Solution		Field Measurements/Component Compliance

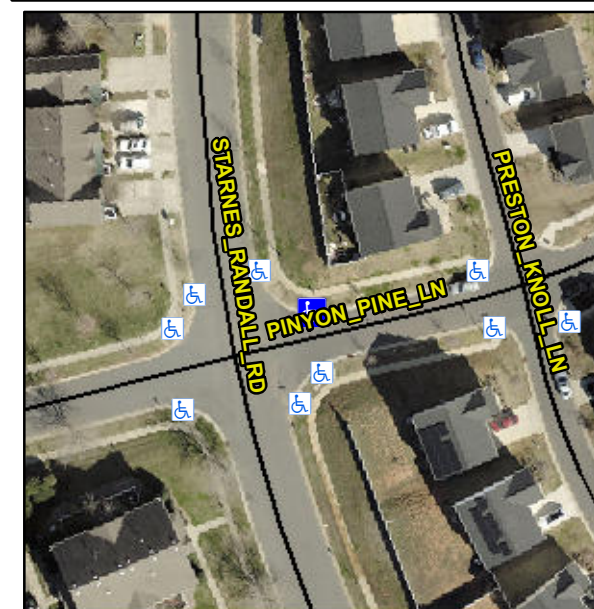
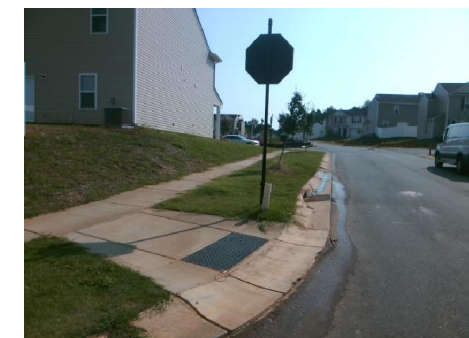
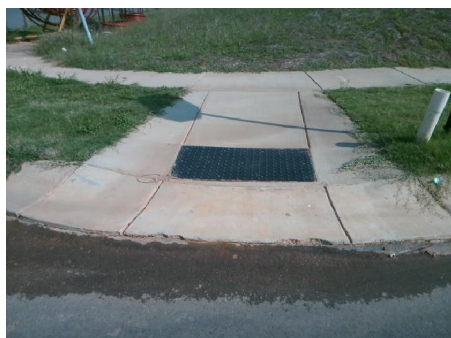
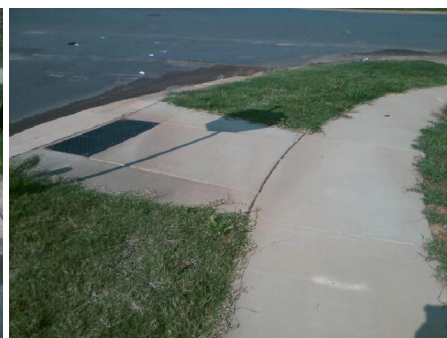
Not Found, R304.5.1, R304.5.3

Compliance	Description	Data	Compliance	Description	Data
N/A	Ramp Length (in)	96.0	Yes	Ramp Slope (%)	6.3
No	Ramp Width (in)	47.5	No	Ramp XSlope (%)	7.7
N/A	Flare Type LT	N/A	N/A	Flare Type RT	N/A
N/A	Flare Slope LT (%)	N/A	N/A	Flare Slope RT (%)	N/A
N/A	Flare Traversable LT?	N/A	N/A	Flare Traversable RT?	N/A
N/A	Landing Length (in)	N/A	N/A	DWS Provided?	N/A
N/A	Landing Width (in)	N/A	N/A	DWS Contrast?	N/A
N/A	Landing Slope (%)	N/A	N/A	DWS Length (in)	N/A
N/A	Landing X Slope (%)	N/A	N/A	DWS Full Width?	N/A
N/A	Landing Curb? (Y/N)	N/A	N/A	DWS Offset (in)	N/A
N/A	Shared Landing?	N/A			
N/A	Gutter Ponding?	Yes	N/A	Gutter Slope (%)	N/A
N/A	Gutter Lip Ht (in)	N/A	N/A	Gutter X Slope (%)	N/A
N/A	Painted X Walk1?	No	N/A	Painted X Walk2?	N/A
	X Walk 1 Direction	To S		X Walk 2 Direction	N/A
N/A	X Walk 1 Width (in)	N/A	N/A	X Walk 2 Width (in)	N/A
	X Walk 1 Slope (%)	0.5		X Walk 2 Slope (%)	N/A
	X Walk 1 X Slope (%)	7.3		X Walk 2 X Slope (%)	N/A

N/A	Ramp inside XWalk1?	N/A	N/A	Ramp inside XWalk2?	N/A
	Road Slope (%)	N/A	N/A	Clear Space?	N/A
	Road X Slope (%)	N/A	N/A	Clear Space to XWalk (in)	N/A
N/A	Any Obstructions?	N/A	N/A	Storm Grate/Utility Hazard?	N/A
	Obstruction Type			Storm Grate/Utility Type	
		N/A			N/A
		Yes		Surface Condition? (G/P)	Good

Remove & Replace Entire Ramp.

Total Cost: \$ 1850.00
