# Access Compliance Report

## Public Rights-of-Way

### (Curb Ramps)

Intersection ID: 46028	Main Street: BEATTIES_FORD_RD	Cross Street: PAULINE_LN	Location: NW
ADA ID: 36C021192B73	Ramp Type: Perp	Initial Pass/Fail: Fail	Overall Compliance: No
		Severity Score: 12.5

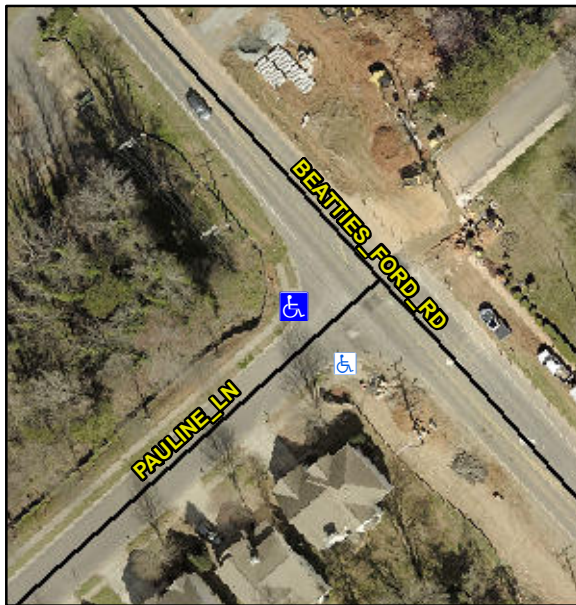
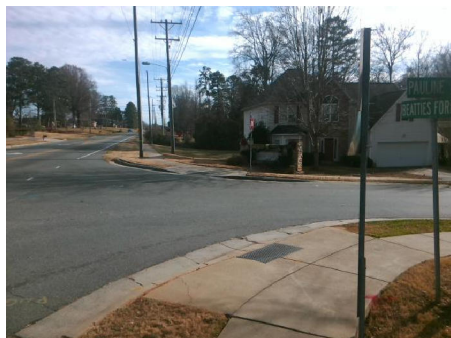
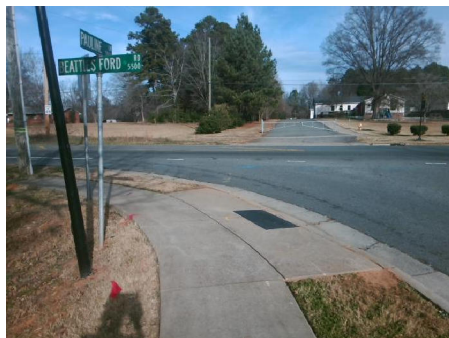
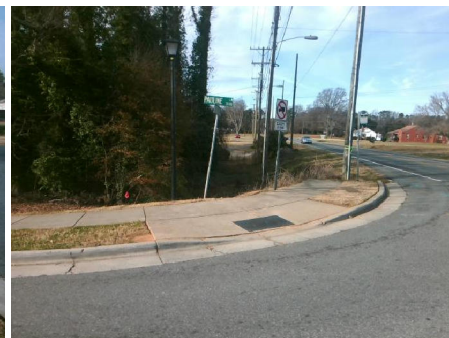
**Not Found, R304.5.3**

Compliance	Description	Data	Compliance	Description	Data
N/A	Ramp Length (in)	48.0	Yes	Ramp Slope (%)	6.6
Yes	Ramp Width (in)	48.0	No	Ramp XSlope (%)	5.3
N/A	Flare Type LT	N/A	N/A	Flare Type RT	N/A
N/A	Flare Slope LT (%)	N/A	N/A	Flare Slope RT (%)	N/A
N/A	Flare Traversable LT?	N/A	N/A	Flare Traversable RT?	N/A
N/A	Landing Length (in)	N/A	N/A	DWS Provided?	N/A
N/A	Landing Width (in)	N/A	N/A	DWS Contrast?	N/A
N/A	Landing Slope (%)	N/A	N/A	DWS Length (in)	N/A
N/A	Landing X Slope (%)	N/A	N/A	DWS Full Width?	N/A
N/A	Landing Curb? (Y/N)	N/A	N/A	DWS Offset (in)	N/A
N/A	Shared Landing?	N/A			
N/A	Gutter Ponding?	N/A	N/A	Gutter Slope (%)	N/A
N/A	Gutter Lip Ht (in)	N/A	N/A	Gutter X Slope (%)	N/A
N/A	Painted X Walk1?	No	N/A	Painted X Walk2?	N/A
	X Walk 1 Direction	To SE		X Walk 2 Direction	N/A
N/A	X Walk 1 Width (in)	N/A	N/A	X Walk 2 Width (in)	N/A
	X Walk 1 Slope (%)	0.4		X Walk 2 Slope (%)	N/A
	X Walk 1 X Slope (%)	4.9		X Walk 2 X Slope (%)	N/A

N/A	Ramp inside XWalk1?	N/A	N/A	Ramp inside XWalk2?	N/A
	Road Slope (%)	N/A	N/A	Clear Space?	N/A
	Road X Slope (%)	N/A	N/A	Clear Space to XWalk (in)	N/A
N/A	Any Obstructions?	N/A	N/A	Storm Grate/Utility Hazard?	N/A
	Obstruction Type			Storm Grate/Utility Type	
		N/A			N/A
			Yes	Surface Condition? (G/P)	Good

**Remove & Replace Entire Ramp.**
