# Access Compliance Report

## Public Rights-of-Way

### (Curb Ramps)

Intersection ID: 30066	Main Street: DAY_LILLY_LN	Cross Street: SUNSET_RD	Location: E
ADA ID: 36C6119180B0	Ramp Type: Perp	Initial Pass/Fail: Fail	Overall Compliance: No
Codes/Mitigation Info/Possible Solution		Field Measurements/Component Compliance	
Severity Score: 26.25

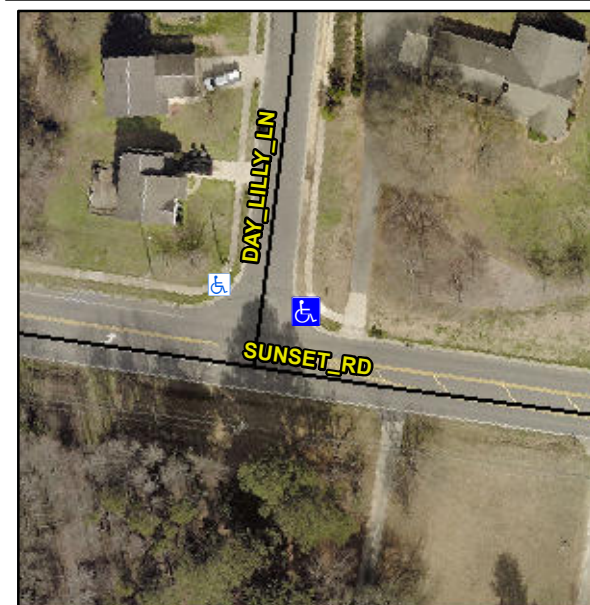
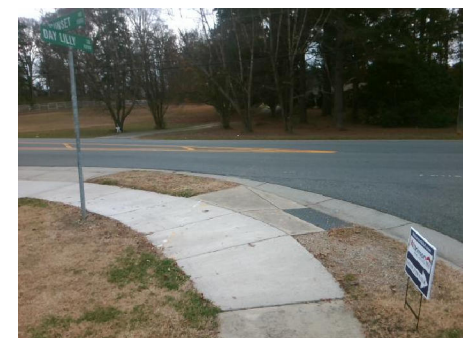
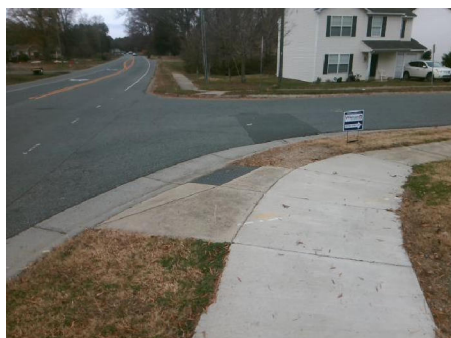
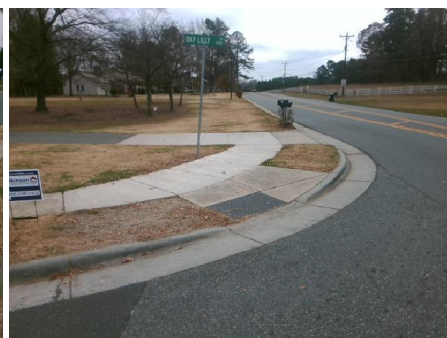
**R304.2.2, R304.5.3**

Compliance	Description	Data	Compliance	Description	Data
N/A	Ramp Length (in)	54.0	No	Ramp Slope (%)	12.7
Yes	Ramp Width (in)	48.0	No	Ramp XSlope (%)	2.2
N/A	Flare Type LT	N/A	N/A	Flare Type RT	N/A
N/A	Flare Slope LT (%)	N/A	N/A	Flare Slope RT (%)	N/A
N/A	Flare Traversable LT?	N/A	N/A	Flare Traversable RT?	N/A
N/A	Landing Length (in)	N/A	N/A	DWS Provided?	N/A
N/A	Landing Width (in)	N/A	N/A	DWS Contrast?	N/A
N/A	Landing Slope (%)	N/A	N/A	DWS Length (in)	N/A
N/A	Landing X Slope (%)	N/A	N/A	DWS Full Width?	N/A
N/A	Landing Curb? (Y/N)	N/A	N/A	DWS Offset (in)	N/A
N/A	Shared Landing?	N/A			
N/A	Gutter Ponding?	N/A	N/A	Gutter Slope (%)	N/A
N/A	Gutter Lip Ht (in)	N/A	N/A	Gutter X Slope (%)	N/A
N/A	Painted X Walk1?	No	N/A	Painted X Walk2?	N/A
	X Walk 1 Direction	To NW		X Walk 2 Direction	N/A
N/A	X Walk 1 Width (in)	N/A	N/A	X Walk 2 Width (in)	N/A
	X Walk 1 Slope (%)	4.7		X Walk 2 Slope (%)	N/A
	X Walk 1 X Slope (%)	1.6		X Walk 2 X Slope (%)	N/A

**Remove & Replace Entire Ramp.**
