# Access Compliance Report

## Public Rights-of-Way

### (Curb Ramps)

Intersection ID: 18947	Main Street: W_TYVOLA_RD	Cross Street: FREE_THROW_LN	Location: SW
ADA ID: 36CAA8DFC069	Ramp Type: PerpDiag	Initial Pass/Fail: Fail	Overall Compliance: No
			Severity Score: 26.25

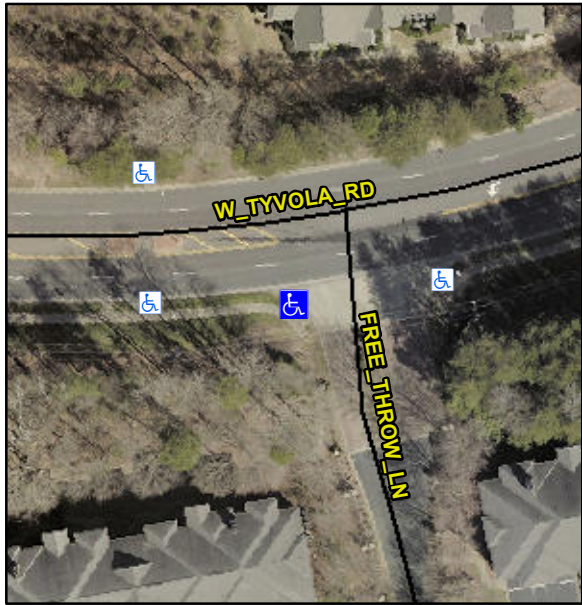
Possible Solutions:		Compliance	Description	Data	Compliance	Description	Data
	Remove & Replace Curb Ramp With Two New Directional Ramps or Equivalent.		N/A	Ramp Length (in)	59.0	No	Ramp Slope (%)	12.2
			Yes	Ramp Width (in)	48.0	No	Ramp XSlope (%)	3.7
			N/A	Flare Type LT	N/A	N/A	Flare Type RT	N/A
			N/A	Flare Slope LT (%)	N/A	N/A	Flare Slope RT (%)	N/A
			N/A	Flare Traversable LT?	N/A	N/A	Flare Traversable RT?	N/A
			N/A	Landing Length (in)	N/A	N/A	DWS Provided?	N/A
			N/A	Landing Width (in)	N/A	N/A	DWS Contrast?	N/A
			N/A	Landing Slope (%)	N/A	N/A	DWS Length (in)	N/A
			N/A	Landing X Slope (%)	N/A	N/A	DWS Full Width?	N/A
Surveyor Notes:		N/A	N/A	Landing Curb? (Y/N)	N/A	N/A	DWS Offset (in)	N/A
PROW/ADA:		R304.2.2, R304.5.3	N/A	Shared Landing?	N/A			
			N/A	Gutter Ponding?	N/A	N/A	Gutter Slope (%)	N/A
			N/A	Gutter Lip Ht (in)	N/A	N/A	Gutter X Slope (%)	N/A
