# Access Compliance Report

## Public Rights-of-Way

### (Curb Ramps)

Intersection ID: 28536	Main Street: SOUTH_STREAM_BV	Cross Street: W_TYVOLA_RD	Location: E
ADA ID: 36CDDDB9E5824	Ramp Type: Para	Initial Pass/Fail: Pass	Overall Compliance: No
Codes/Mitigation Info/Possible Solution		Field Measurements/Component Compliance	
Severity Score: 0

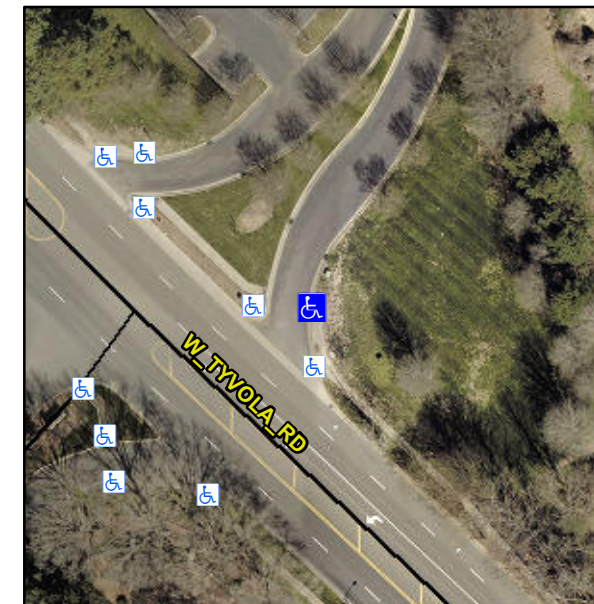
**LT RP < 5%**

**Not Found, R304.2.1**

Compliance	Description	Data	Compliance	Description	Data
N/A	Ramp Length LT (in)	69.0	N/A	Ramp Length RT (in)	59.0
Yes	Ramp Width LT (in)	60.0	Yes	Ramp Width RT (in)	60.0
Yes	Ramp Slope LT (%)	3.3	Yes	Ramp Slope RT (%)	1.2
Yes	Ramp XSlope LT (%)	0.7	Yes	Ramp XSlope RT (%)	1.6
Yes	Landing Length (in)	60.0	Yes	DWS Provided?	Yes
No	Landing Width (in)	43.0	Yes	DWS Contrast?	Yes
Yes	Landing Slope (%)	0.6	Yes	DWS Length (in)	24.0
Yes	Landing X Slope (%)	0.9	Yes	DWS Full Width?	Yes
N/A	Landing Curb? (Y/N)	No	Yes	DWS Offset (in)	2.0
N/A	Shared Landing?	No			
Yes	Gutter Ponding?	No	Yes	Gutter Slope (%)	0.5
Yes	Gutter Lip Ht (in)	0.0	Yes	Gutter X Slope (%)	1.2
N/A	Painted X Walk1?	No	N/A	Painted X Walk2?	N/A
	X Walk 1 Direction	To NW		X Walk 2 Direction	N/A
N/A	X Walk 1 Width (in)	N/A	N/A	X Walk 2 Width (in)	N/A
	X Walk 1 Slope (%)	0.5		X Walk 2 Slope (%)	N/A
	X Walk 1 X Slope (%)	1.1		X Walk 2 X Slope (%)	N/A
N/A	Ramp inside XWalk1?	N/A	N/A	Ramp inside XWalk2?	N/A

Road Slope (%)	N/A	N/A	Clear Space?	Yes
	Road X Slope (%)	N/A	N/A	Clear Space to XWalk (in)	N/A
Yes	Any Obstructions?	No	Yes	Storm Grate/Utility Hazard?	No
	Obstruction Type			Storm Grate/Utility Type	
		N/A			N/A
			Yes	Surface Condition? (G/P)	Good
			Replace	Curb Slope (%)	9.0

**Remove & Replace Entire Ramp.**
