Intersection ID: 22502	Main Street: SHARON_VIEW_RD	Cross Street: OLD_PROVIDENCE_RD	Location:	NW
ADA ID: 36CFDA7522E9	Ramp Type: PerpDiag	Initial Pass/Fail: Fail	Overall Compliance: No	Severity Score: 46.25

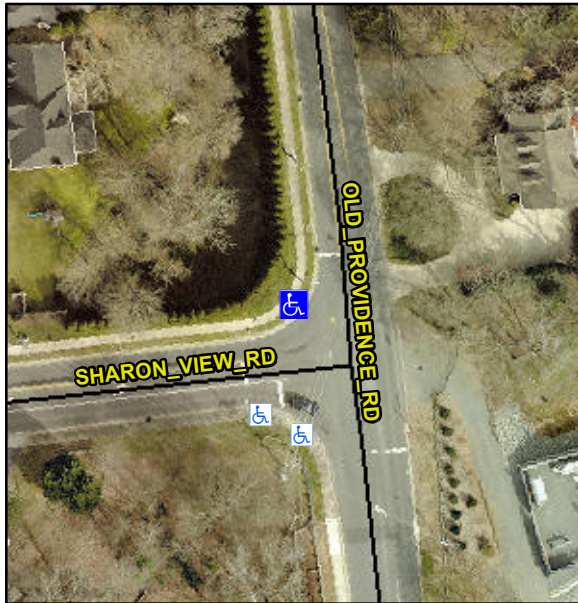
**Not Found, R304.5.1, R304.2.2,
R304.5.3**

Compliance	Description	Data	Compliance	Description	Data
N/A	Ramp Length (in)	47.0	No	Ramp Slope (%)	8.7
No	Ramp Width (in)	43.0	No	Ramp XSlope (%)	7.5
N/A	Flare Type LT	N/A	N/A	Flare Type RT	N/A
N/A	Flare Slope LT (%)	N/A	N/A	Flare Slope RT (%)	N/A
N/A	Flare Traversable LT?	N/A	N/A	Flare Traversable RT?	N/A
N/A	Landing Length (in)	N/A	N/A	DWS Provided?	N/A
N/A	Landing Width (in)	N/A	N/A	DWS Contrast?	N/A
N/A	Landing Slope (%)	N/A	N/A	DWS Length (in)	N/A
N/A	Landing X Slope (%)	N/A	N/A	DWS Full Width?	N/A
N/A	Landing Curb? (Y/N)	N/A	N/A	DWS Offset (in)	N/A
N/A	Shared Landing?	N/A			
N/A	Gutter Ponding?	N/A	N/A	Gutter Slope (%)	N/A
N/A	Gutter Lip Ht (in)	N/A	N/A	Gutter X Slope (%)	N/A
N/A	Painted X Walk1?	No	N/A	Painted X Walk2?	No
	X Walk 1 Direction	To S		X Walk 2 Direction	To E
N/A	X Walk 1 Width (in)	N/A	N/A	X Walk 2 Width (in)	N/A
	X Walk 1 Slope (%)	2.7		X Walk 2 Slope (%)	1.9
	X Walk 1 X Slope (%)	2.2		X Walk 2 X Slope (%)	4.3

N/A	Ramp inside XWalk1?	N/A	N/A	Ramp inside XWalk2?	N/A
	Road Slope (%)	4.0	N/A	Clear Space?	N/A
	Road X Slope (%)	0.4	N/A	Clear Space to XWalk (in)	N/A
N/A	Any Obstructions?	N/A	N/A	Storm Grate/Utility Hazard?	N/A
	Obstruction Type			Storm Grate/Utility Type	
		N/A			N/A
			Yes	Surface Condition? (G/P)	Good

Possible Solutions:

Remove & Replace Curb Ramp With Two New Directional Ramps or Equivalent.

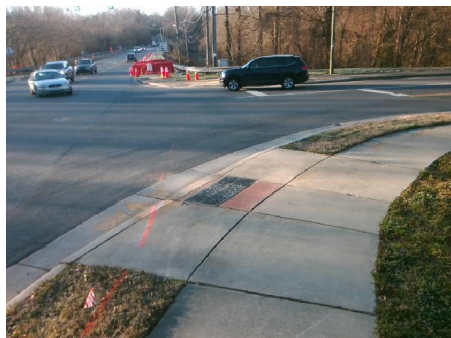
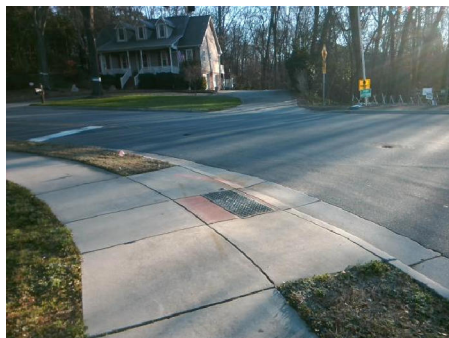
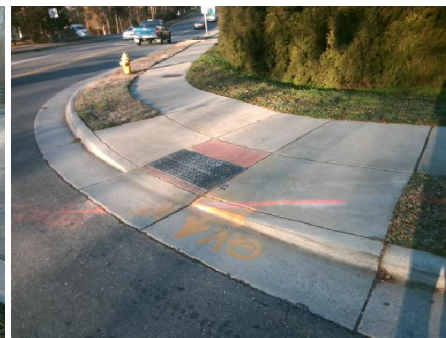
Street 1 Name	SHARON VIEW RD
Stop Condition-Street 2	Signal
Street 2 Name	OLD PROVIDENCE RD
Stop Condition-Street 1	Signal
