# Access Compliance Report

## Public Rights-of-Way

### (Curb Ramps)

Intersection ID: 29647	Main Street: BALLYSHANNON_LN	Cross Street: SOUTHERN_GARDEN_LN	Location: SW
ADA ID: 36D064FDC239	Ramp Type: BlendTrans1	Initial Pass/Fail: Fail	Overall Compliance: No
Severity Score: 18.75			
Codes/Mitigation Info/Possible Solution		Field Measurements/Component Compliance

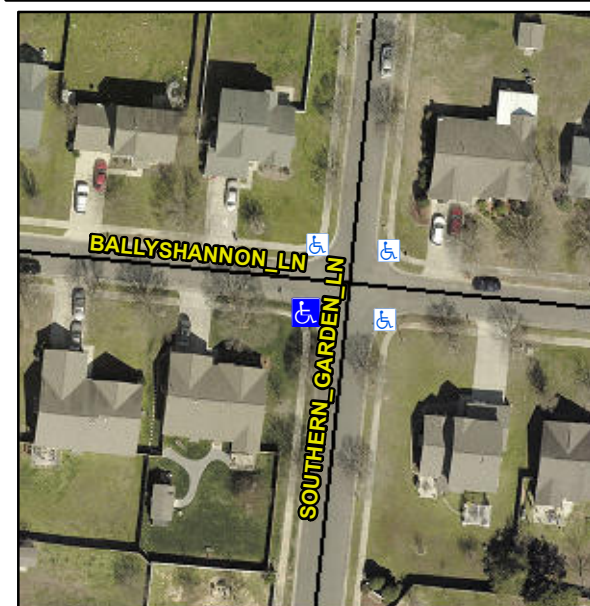
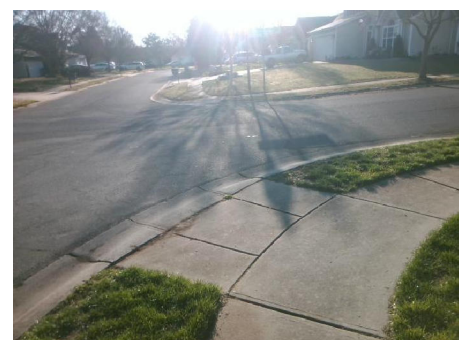
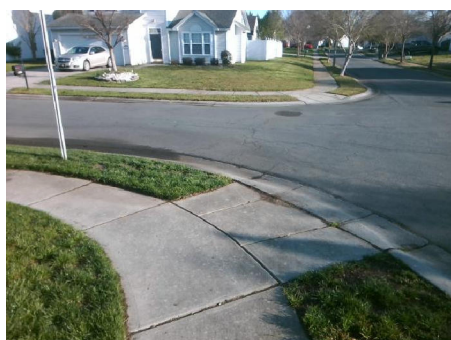
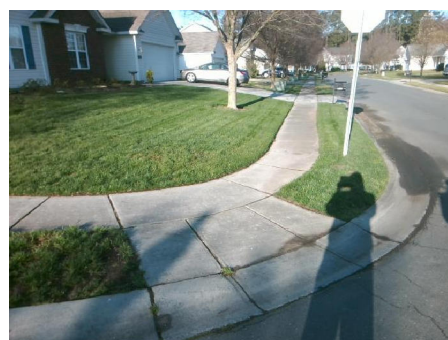
Compliance	Description	Data	Compliance	Description	Data
N/A	Ramp Length (in)	48.0	Yes	BlendTrans Slope (%)	4.7
No	Ramp Width (in)	34.5	No	BlendTrans XSlope (%)	4.1
N/A	Flare Type LT	N/A	N/A	Flare Type RT	N/A
N/A	Flare Slope LT (%)	N/A	N/A	Flare Slope RT (%)	N/A
N/A	Flare Traversable LT?	N/A	N/A	Flare Traversable RT?	N/A
N/A	Landing Length (in)	N/A	N/A	DWS Provided?	N/A
N/A	Landing Width (in)	N/A	N/A	DWS Contrast?	N/A
N/A	Landing Slope (%)	N/A	N/A	DWS Length (in)	N/A
N/A	Landing X Slope (%)	N/A	N/A	DWS Full Width?	N/A
N/A	Landing Curb? (Y/N)	N/A	N/A	DWS Offset (in)	N/A
N/A	Shared Landing?	N/A			
N/A	Gutter Ponding?	N/A	N/A	Gutter Slope (%)	N/A
N/A	Gutter Lip Ht (in)	N/A	N/A	Gutter X Slope (%)	N/A
N/A	Painted X Walk1?	No	N/A	Painted X Walk2?	No
	X Walk 1 Direction	To E		X Walk 2 Direction	To N
	X Walk 1 Width (in)	N/A		X Walk 2 Width (in)	N/A
	X Walk 1 Slope (%)	0.9		X Walk 2 Slope (%)	2.0
	X Walk 1 X Slope (%)	0.2		X Walk 2 X Slope (%)	1.9

N/A	Ramp inside XWalk1?	N/A	N/A	Ramp inside XWalk2?	N/A
	Road Slope (%)	0.6		Clear Space?	N/A
	Road X Slope (%)	0.8	N/A	Clear Space to XWalk (in)	N/A
N/A	Any Obstructions?	N/A	N/A	Storm Grate/Utility Hazard?	N/A
	Obstruction Type			Storm Grate/Utility Type	
		N/A			N/A
			Yes	Surface Condition? (G/P)	Good
			N/A	Curb Slope (%)	2.1

**Remove & Replace Curb Ramp With Two New Directional Ramps or Equivalent.**

**R304.5.1, R304.5.3**
