Access Compliance Report

Public Rights-of-Way

(Curb Ramps)

Intersection ID: 10024336	Main Street: CREEKRIDGE_RD	Cross Street: N/A	Location: NE
ADA ID: 36E3FAB62DCC	Ramp Type: Directional1	Initial Pass/Fail: Pass	Overall Compliance: No
			Severity Score: 2.5

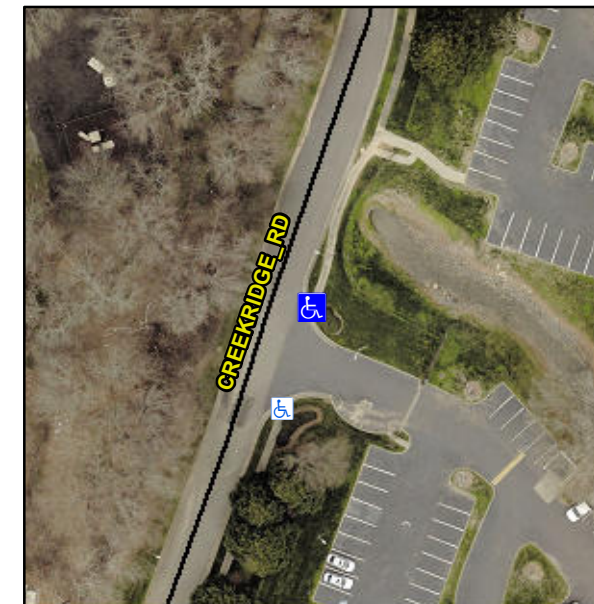
Compliance	Description	Data	Compliance	Description	Data
N/A	Ramp Length (in)	49.0	Yes	Grade Break?	Yes
Yes	Ramp Width (in)	51.0	No	Grade Break Slope (%)	8.2
Yes	Ramp Slope (%)	4.0	Yes	Grade Break XSlope (%)	0.6
Yes	Ramp XSlope (%)	1.3			
N/A	Flare Type LT	N/A	N/A	Flare Type RT	N/A
N/A	Flare Slope LT (%)	N/A	N/A	Flare Slope RT (%)	N/A
N/A	Flare Traversable LT?	N/A	N/A	Flare Traversable RT?	N/A
Yes	Landing Length (in)	58.5	Yes	DWS Provided?	Yes
No	Landing Width (in)	47.5	Yes	DWS Contrast?	Yes
Yes	Landing Slope (%)	0.1	No	DWS Length (in)	23.5
Yes	Landing X Slope (%)	2.3	No	DWS Full Width?	No
N/A	Landing Curb? (Y/N)	N/A	No	DWS Offset LT (in)	10.0
N/A	Shared Landing?	No	No	DWS Offset RT (in)	69.0
Yes	Gutter Ponding?	No	Yes	Gutter Slope (%)	3.2
Yes	Gutter Lip Ht (in)	0.0	Yes	Gutter X Slope (%)	2.6
N/A	Painted X Walk1?	No		Road Slope (%)	3.8
	X Walk 1 Direction	To S		Road X Slope (%)	12.2
	X Walk 1 Width (in)	N/A		Clear Space?	Yes

X Walk 1 Slope (%)	3.8	N/A	Clear Space to XWalk (in)	N/A
	X Walk 1 X Slope (%)	12.2	Yes	Storm Grate/Utility Hazard?	No
N/A	Ramp inside XWalk1?	N/A		Storm Grate/Utility Type	
Yes	Any Obstructions?	No			N/A
	Obstruction Type		Yes	Surface Condition? (G/P)	Good
			N/A	Curb Slope (%)	0.5

Possible Solutions:

Remove & Replace Entire Ramp.

R304.2.1, R304.5.3, R305.1.4, R305.2
