# Access Compliance Report

## Public Rights-of-Way

### (Curb Ramps)

Intersection ID: 11698	Main Street: S_CEDAR_ST	Cross Street: W_4TH_ST	Location: S
ADA ID: 36EBDF4A0165	Ramp Type: PerpDiag	Initial Pass/Fail: Fail	Overall Compliance: No
		Severity Score: 25

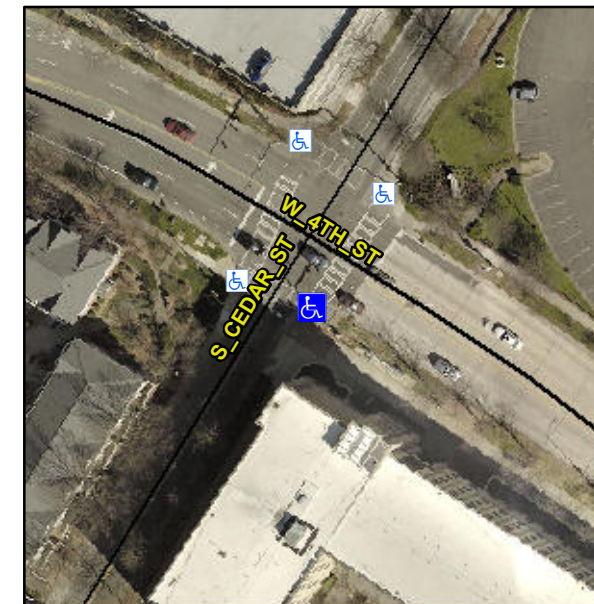
**Not Found, R304.2.2, R304.5.3**

Compliance	Description	Data	Compliance	Description	Data
N/A	Ramp Length (in)	60.0	No	Ramp Slope (%)	9.6
Yes	Ramp Width (in)	68.0	No	Ramp XSlope (%)	6.0
N/A	Flare Type LT	N/A	N/A	Flare Type RT	N/A
N/A	Flare Slope LT (%)	N/A	N/A	Flare Slope RT (%)	N/A
N/A	Flare Traversable LT?	N/A	N/A	Flare Traversable RT?	N/A
N/A	Landing Length (in)	N/A	N/A	DWS Provided?	N/A
N/A	Landing Width (in)	N/A	N/A	DWS Contrast?	N/A
N/A	Landing Slope (%)	N/A	N/A	DWS Length (in)	N/A
N/A	Landing X Slope (%)	N/A	N/A	DWS Full Width?	N/A
N/A	Landing Curb? (Y/N)	N/A	N/A	DWS Offset (in)	N/A
N/A	Shared Landing?	N/A			
N/A	Gutter Ponding?	N/A	N/A	Gutter Slope (%)	N/A
N/A	Gutter Lip Ht (in)	N/A	N/A	Gutter X Slope (%)	N/A
N/A	Painted X Walk1?	Yes	N/A	Painted X Walk2?	Yes
	X Walk 1 Direction	To NE		X Walk 2 Direction	To NW
N/A	X Walk 1 Width (in)	109.0	N/A	X Walk 2 Width (in)	102.0
	X Walk 1 Slope (%)	2.8		X Walk 2 Slope (%)	2.5
	X Walk 1 X Slope (%)	1.2		X Walk 2 X Slope (%)	2.4

N/A	Ramp inside XWalk1?	Yes	N/A	Ramp inside XWalk2?	Yes
	Road Slope (%)	2.7	N/A	Clear Space?	N/A
	Road X Slope (%)	2.9	N/A	Clear Space to XWalk (in)	N/A
N/A	Any Obstructions?	N/A	N/A	Storm Grate/Utility Hazard?	N/A
	Obstruction Type			Storm Grate/Utility Type	
		N/A			N/A
		Yes		Surface Condition? (G/P)	Good

**Remove & Replace Curb Ramp With Two New Directional Ramps or Equivalent.**
