Access Compliance Report

Public Rights-of-Way

(Curb Ramps)

Intersection ID: 50599	Main Street: HEARTLEAF_RD	Cross Street: STREAM_ORCHID_LN	Location: NW
ADA ID: 36F44EE121AD	Ramp Type: Perp	Initial Pass/Fail: Fail	Overall Compliance: No
		Severity Score: 12.5

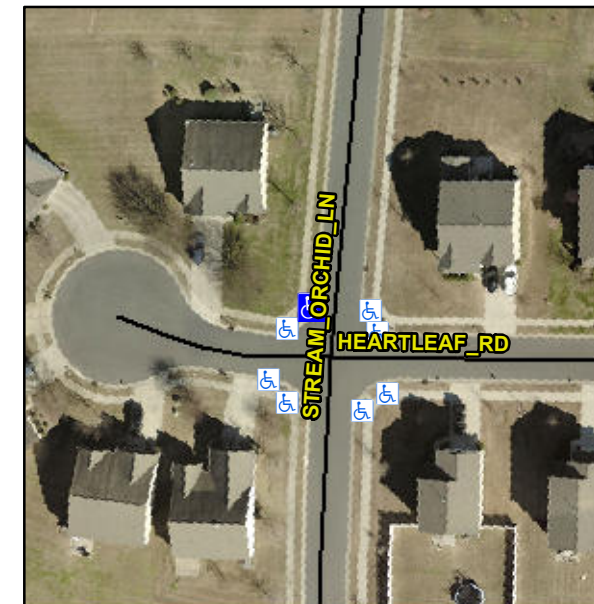
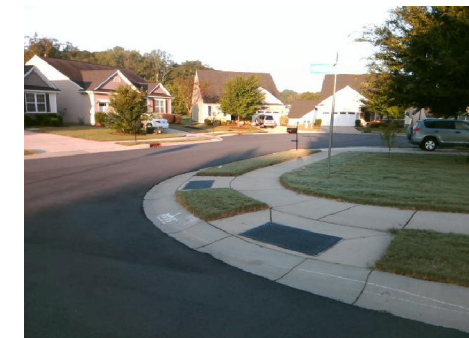
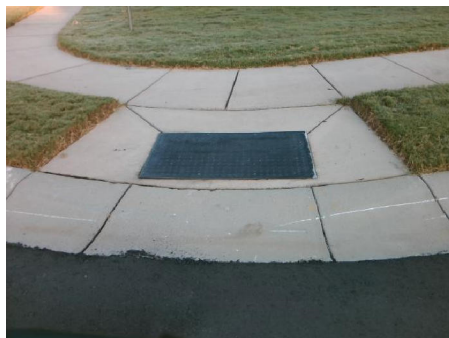
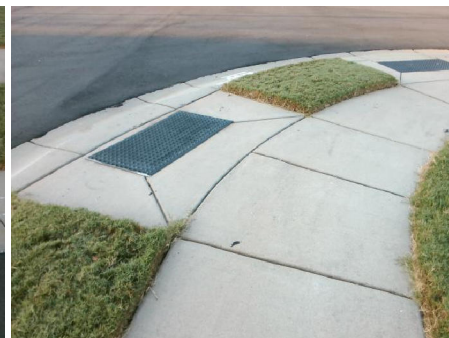
Not Found, R304.5.3

Compliance	Description	Data	Compliance	Description	Data
N/A	Ramp Length (in)	47.0	Yes	Ramp Slope (%)	5.4
Yes	Ramp Width (in)	48.0	No	Ramp XSlope (%)	6.1
N/A	Flare Type LT	N/A	N/A	Flare Type RT	N/A
N/A	Flare Slope LT (%)	N/A	N/A	Flare Slope RT (%)	N/A
N/A	Flare Traversable LT?	N/A	N/A	Flare Traversable RT?	N/A
N/A	Landing Length (in)	N/A	N/A	DWS Provided?	N/A
N/A	Landing Width (in)	N/A	N/A	DWS Contrast?	N/A
N/A	Landing Slope (%)	N/A	N/A	DWS Length (in)	N/A
N/A	Landing X Slope (%)	N/A	N/A	DWS Full Width?	N/A
N/A	Landing Curb? (Y/N)	N/A	N/A	DWS Offset (in)	N/A
N/A	Shared Landing?	N/A			
N/A	Gutter Ponding?	N/A	N/A	Gutter Slope (%)	N/A
N/A	Gutter Lip Ht (in)	N/A	N/A	Gutter X Slope (%)	N/A
N/A	Painted X Walk1?	No	N/A	Painted X Walk2?	N/A
	X Walk 1 Direction	To E		X Walk 2 Direction	N/A
N/A	X Walk 1 Width (in)	N/A	N/A	X Walk 2 Width (in)	N/A
	X Walk 1 Slope (%)	4.2		X Walk 2 Slope (%)	N/A
	X Walk 1 X Slope (%)	2.8		X Walk 2 X Slope (%)	N/A

Remove & Replace Entire Ramp.
