Access Compliance Report

Public Rights-of-Way

(Curb Ramps)

Intersection ID: 16889	Main Street: ANNLIN_AV	Cross Street: REYNOLDS_DR	Location: S
ADA ID: 36F9EB7B8A5B	Ramp Type: PerpDiag	Initial Pass/Fail: Fail	Overall Compliance: No
Codes/Mitigation Info/Possible Solution		Field Measurements/Component Compliance	
Severity Score: 12.5

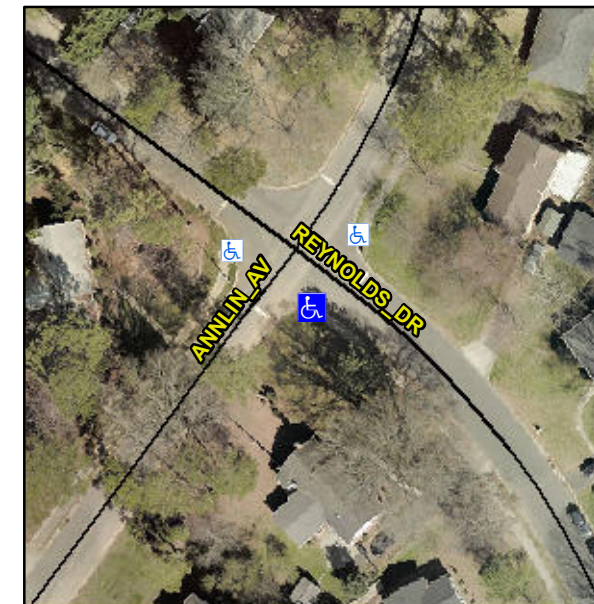
Not Found, R304.5.3

Compliance	Description	Data	Compliance	Description	Data
N/A	Ramp Length (in)	58.0	Yes	Ramp Slope (%)	5.5
Yes	Ramp Width (in)	48.0	No	Ramp XSlope (%)	5.7
N/A	Flare Type LT	N/A	N/A	Flare Type RT	N/A
N/A	Flare Slope LT (%)	N/A	N/A	Flare Slope RT (%)	N/A
N/A	Flare Traversable LT?	N/A	N/A	Flare Traversable RT?	N/A
N/A	Landing Length (in)	N/A	N/A	DWS Provided?	N/A
N/A	Landing Width (in)	N/A	N/A	DWS Contrast?	N/A
N/A	Landing Slope (%)	N/A	N/A	DWS Length (in)	N/A
N/A	Landing X Slope (%)	N/A	N/A	DWS Full Width?	N/A
N/A	Landing Curb? (Y/N)	N/A	N/A	DWS Offset (in)	N/A
N/A	Shared Landing?	N/A			
N/A	Gutter Ponding?	N/A	N/A	Gutter Slope (%)	N/A
N/A	Gutter Lip Ht (in)	N/A	N/A	Gutter X Slope (%)	N/A
N/A	Painted X Walk1?	No	N/A	Painted X Walk2?	No
	X Walk 1 Direction	To NE		X Walk 2 Direction	To NW
N/A	X Walk 1 Width (in)	N/A	N/A	X Walk 2 Width (in)	N/A
	X Walk 1 Slope (%)	4.1		X Walk 2 Slope (%)	6.0
	X Walk 1 X Slope (%)	4.2		X Walk 2 X Slope (%)	1.8

N/A	Ramp inside XWalk1?	N/A	N/A	Ramp inside XWalk2?	N/A
	Road Slope (%)	2.7	N/A	Clear Space?	N/A
	Road X Slope (%)	6.5	N/A	Clear Space to XWalk (in)	N/A
N/A	Any Obstructions?	N/A	N/A	Storm Grate/Utility Hazard?	N/A
	Obstruction Type			Storm Grate/Utility Type	
		N/A			N/A
			Yes	Surface Condition? (G/P)	Good

Remove & Replace Curb Ramp With Two New Directional Ramps or Equivalent.

Total Cost: \$ 3200.00
