Access Compliance Report

Public Rights-of-Way

(Curb Ramps)

Intersection ID: 53380	Main Street: IKEA_BV	Cross Street: LEWIS_ST	Location: S
ADA ID: 36FBF3C8874F	Ramp Type: Directional1	Initial Pass/Fail: Pass	Overall Compliance: No
Codes/Mitigation Info/Possible Solution		Field Measurements/Component Compliance	
Severity Score: 7.5

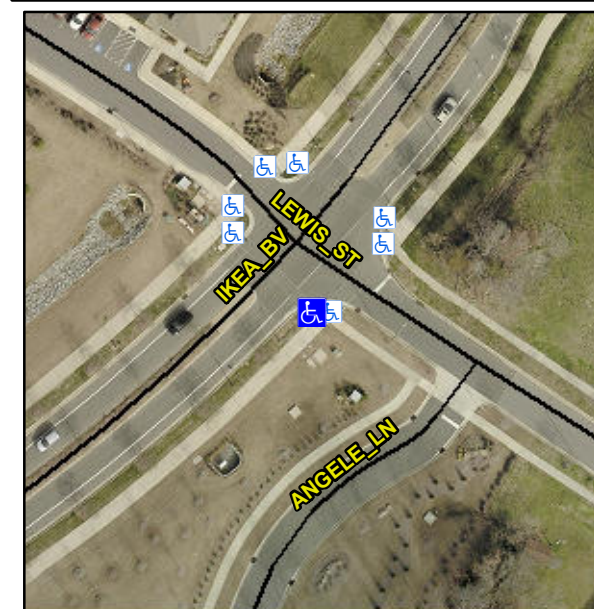
Compliance	Description	Data	Compliance	Description	Data
N/A	Ramp Length (in)	41.0	No	Grade Break?	No
Yes	Ramp Width (in)	73.0	N/A	Grade Break Slope (%)	N/A
Yes	Ramp Slope (%)	7.6	N/A	Grade Break XSlope (%)	N/A
Yes	Ramp XSlope (%)	0.2			
Yes	Flare Type LT	N/A	Yes	Flare Type RT	N/A
N/A	Flare Slope LT (%)	N/A	N/A	Flare Slope RT (%)	N/A
N/A	Flare Traversable LT?	No	N/A	Flare Traversable RT?	No
Yes	Landing Length (in)	95.0	Yes	DWS Provided?	Yes
Yes	Landing Width (in)	87.0	Yes	DWS Contrast?	Yes
Yes	Landing Slope (%)	0.6	Yes	DWS Length (in)	24.0
Yes	Landing X Slope (%)	0.3	Yes	DWS Full Width?	Yes
N/A	Landing Curb? (Y/N)	N/A	Yes	DWS Offset LT (in)	0.0
N/A	Shared Landing?	Yes	Yes	DWS Offset RT (in)	0.0
Yes	Gutter Ponding?	No	Yes	Gutter Slope (%)	0.5
No	Gutter Lip Ht (in)	0.3	No	Gutter X Slope (%)	5.7
N/A	Painted X Walk1?	Yes		Road Slope (%)	2.5
	X Walk 1 Direction	To NW		Road X Slope (%)	4.4
	X Walk 1 Width (in)	58.0		Clear Space?	Yes

X Walk 1 Slope (%)	2.5	N/A	Clear Space to XWalk (in)	N/A
	X Walk 1 X Slope (%)	4.4	Yes	Storm Grate/Utility Hazard?	No
Yes	Ramp inside XWalk1?	Yes		Storm Grate/Utility Type	
Yes	Any Obstructions?	No			N/A
	Obstruction Type		Yes	Surface Condition? (G/P)	Good
			N/A	Curb Slope (%)	N/A

Possible Solutions:

**Remove & Replace Entire Ramp.
Remove & Replace Gutter.**

R304.5.2, R302.7.2, R304.5.3
