Access Compliance Report

Public Rights-of-Way

(Curb Ramps)

Intersection ID: 52927	Main Street: EMORY_OAK_DR	Cross Street: GRAY_OAK_LN	Location: W
ADA ID: 36FDC5344519	Ramp Type: BlendTrans1	Initial Pass/Fail: Fail	Overall Compliance: No
Severity Score: 10			
Codes/Mitigation Info/Possible Solution		Field Measurements/Component Compliance

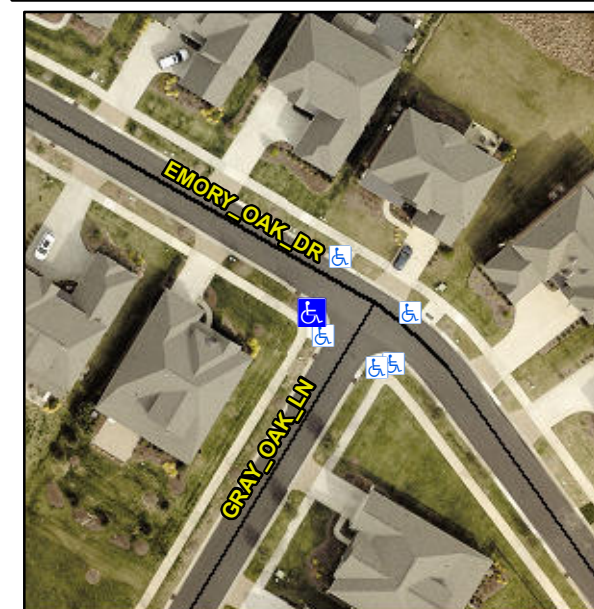
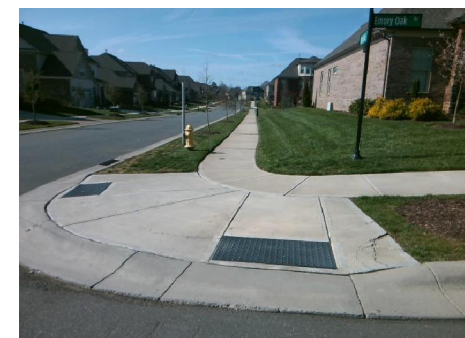
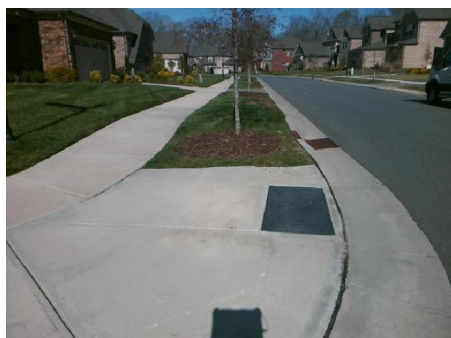
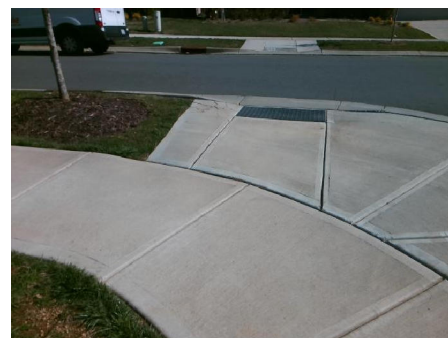
Compliance	Description	Data	Compliance	Description	Data
N/A	Ramp Length (in)	100.5	Yes	BlendTrans Slope (%)	3.2
No	Ramp Width (in)	46.5	Yes	BlendTrans XSlope (%)	2.9
N/A	Flare Type LT	N/A	N/A	Flare Type RT	N/A
N/A	Flare Slope LT (%)	N/A	N/A	Flare Slope RT (%)	N/A
N/A	Flare Traversable LT?	N/A	N/A	Flare Traversable RT?	N/A
N/A	Landing Length (in)	N/A	N/A	DWS Provided?	N/A
N/A	Landing Width (in)	N/A	N/A	DWS Contrast?	N/A
N/A	Landing Slope (%)	N/A	N/A	DWS Length (in)	N/A
N/A	Landing X Slope (%)	N/A	N/A	DWS Full Width?	N/A
N/A	Landing Curb? (Y/N)	N/A	N/A	DWS Offset (in)	N/A
N/A	Shared Landing?	N/A			
N/A	Gutter Ponding?	N/A	N/A	Gutter Slope (%)	N/A
N/A	Gutter Lip Ht (in)	N/A	N/A	Gutter X Slope (%)	N/A
N/A	Painted X Walk1?	No	N/A	Painted X Walk2?	N/A
	X Walk 1 Direction	To NE		X Walk 2 Direction	N/A
	X Walk 1 Width (in)	N/A		X Walk 2 Width (in)	N/A
	X Walk 1 Slope (%)	4.3		X Walk 2 Slope (%)	N/A
	X Walk 1 X Slope (%)	4.1		X Walk 2 X Slope (%)	N/A

N/A	Ramp inside XWalk1?	N/A	N/A	Ramp inside XWalk2?	N/A
	Road Slope (%)	4.1		Clear Space?	N/A
	Road X Slope (%)	4.3	N/A	Clear Space to XWalk (in)	N/A
N/A	Any Obstructions?	N/A	N/A	Storm Grate/Utility Hazard?	N/A
	Obstruction Type			Storm Grate/Utility Type	
		N/A			N/A
			Yes	Surface Condition? (G/P)	Good
			N/A	Curb Slope (%)	0.7

Possible Solutions:

Remove & Replace Curb Ramp With Two New Directional Ramps or Equivalent.
