Access Compliance Report

Public Rights-of-Way

(Curb Ramps)

Intersection ID: 10939	Main Street: MONTGOMERY_ST	Cross Street: FLINT_ST	Location:	E
ADA ID: 3706D035A49A	Ramp Type: Combination1	Initial Pass/Fail: Fail	Overall Compliance: No	Severity Score: 72.5
Codes/Mitigation Info/Possible Solution		Field Measurements/Component Compliance

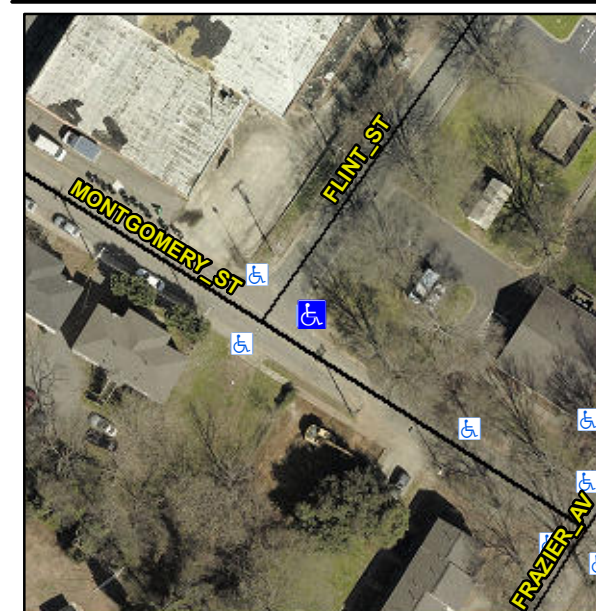
RP < 5%

R304.5.1, R304.5.3, R304.3.2

Compliance	Description	Data	Compliance	Description	Data
N/A	Ramp Length LT (in)	60.0	N/A	Ramp Length RT (in)	55.0
Yes	Ramp Width LT (in)	49.0	Yes	Ramp Width RT (in)	71.0
No	Ramp Slope LT (%)	8.5	No	Ramp Slope RT (%)	9.2
Yes	Ramp XSlope LT (%)	1.5	No	Ramp XSlope RT (%)	6.6
N/A	Ramp Length (in)	60.0	Yes	Ramp Slope (%)	4.5
No	Ramp Width (in)	29.0	No	Ramp XSlope (%)	15.0
N/A	Flare Type LT	N/A	N/A	Flare Type RT	N/A
N/A	Flare Slope LT (%)	N/A	N/A	Flare Slope RT (%)	N/A
N/A	Flare Traversable LT?	N/A	N/A	Flare Traversable RT?	N/A
N/A	Landing Length (in)	N/A	N/A	DWS Provided?	N/A
N/A	Landing Width (in)	N/A	N/A	DWS Contrast?	N/A
N/A	Landing Slope (%)	N/A	N/A	DWS Length (in)	N/A
N/A	Landing X Slope (%)	N/A	N/A	DWS Full Width?	N/A
N/A	Landing Curb? (Y/N)	N/A	N/A	DWS Offset (in)	N/A
N/A	Shared Landing?	N/A			
N/A	Gutter Ponding?	N/A	N/A	Gutter Slope (%)	N/A
N/A	Gutter Lip Ht (in)	N/A	N/A	Gutter X Slope (%)	N/A
N/A	Painted X Walk1?	No	N/A	Painted X Walk2?	N/A

Possible Solutions:

Remove & Replace Entire Ramp.

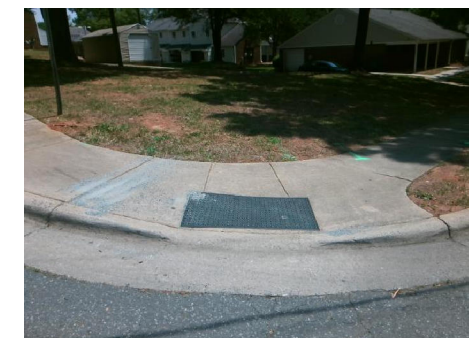
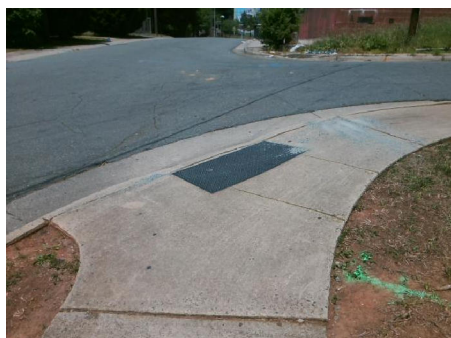
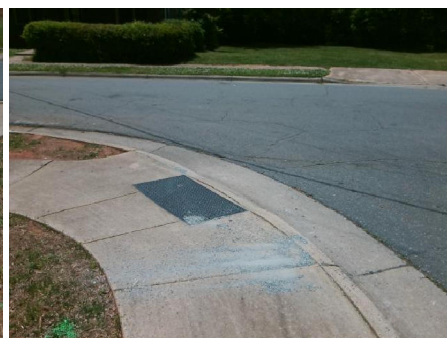
X Walk 1 Direction	To NE		X Walk 2 Direction	N/A
	X Walk 1 Width (in)	N/A		X Walk 2 Width (in)	N/A
	X Walk 1 Slope (%)	8.0		X Walk 2 Slope (%)	N/A
	X Walk 1 X Slope (%)	5.1		X Walk 2 X Slope (%)	N/A
N/A	Ramp inside XWalk1?	N/A	N/A	Ramp inside XWalk2?	N/A
	Road Slope (%)	N/A		Clear Space?	N/A
	Road X Slope (%)	N/A	N/A	Clear Space to XWalk (in)	N/A
			N/A	Any Obstruction?	N/A
				Obstruction Type	N/A
			N/A	Storm Grate/Utility Hazard?	N/A
				Storm Grate/Utility Type	N/A
Yes	Surface Condition? (G/P)	Good			
	Curb Slope (%)	N/A
