Access Compliance Report

Public Rights-of-Way

(Curb Ramps)

Intersection ID: N/A		Main Street: HARLEE_AV		Cross Street: N/A		Location: NW											
ADA ID: 370A6052CD08		Ramp Type: Directional2		Initial Pass/Fail: Fail		Overall Compliance: No		Severity Score: 17.5									
Codes/Mitigation Info/Possible Solution				Field Measurements/Component Compliance													
<div>

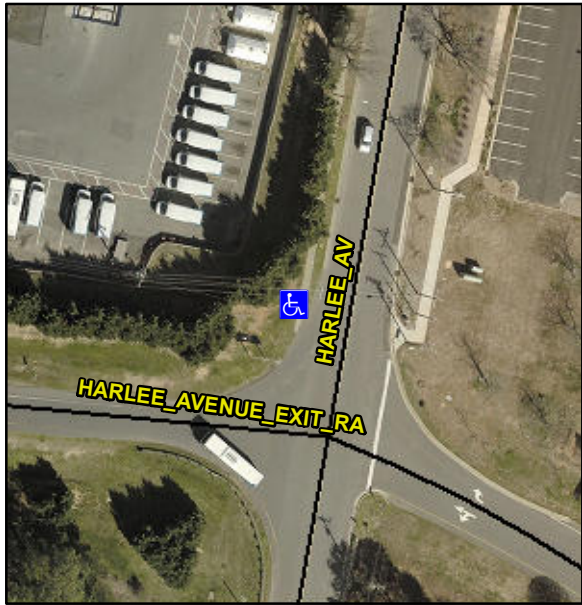
</div> <div>Possible Solutions:</div> <div>Remove & Replace Entire Ramp.</div> <div>Surveyor Notes:</div> <div>N/A</div> <div>PROW/ADA:</div> <div>R304.5.1</div> <div>Street 1 Name</div> <div>HARLEE AV EXIT RA</div> <div>Stop Condition-Street 1</div> <div>None</div> <div>Street 2 Name</div> <div>N/A</div> <div>Stop Condition-Street 2</div> <div>N/A</div> <div>Total Cost:</div> <div>\$</div> <div>1800.00</div>				Compliance		Description		Data		Compliance		Description		Data			
				N/A		Ramp Length (in)		144.0		N/A		Grade Break?		N/A			
				No		Ramp Width (in)		32.0		N/A		Grade Break Slope (%)		0.0

Yes		Ramp Slope (%)		4.8		N/A		Grade Break XSlope (%)		0.0			
				Yes		Ramp XSlope (%)		0.5									
				N/A		Flare Type LT		N/A		N/A		Flare Type RT		N/A			
				N/A		Flare Slope LT (%)		N/A		N/A		Flare Slope RT (%)		0.0			
				N/A		Flare Traversable LT?		N/A		N/A		Flare Traversable RT?		N/A			
				N/A		Landing Length (in)		0.0		N/A		DWS Provided?		N/A			
				N/A		Landing Width (in)		0.0		N/A		DWS Contrast?		N/A			
				N/A		Landing Slope (%)		0.0		N/A		DWS Length (in)		N/A			
				N/A		Landing X Slope (%)		0.0		N/A		DWS Full Width?		N/A			
				N/A		Landing Curb? (Y/N)		N/A		N/A		DWS Offset LT (in)		N/A			
				N/A		Shared Landing?		N/A		N/A		DWS Offset RT (in)		N/A			
				N/A		Gutter Ponding?		0.0		N/A		Gutter Slope (%)		N/A			
				N/A		Gutter Lip Ht (in)		0.0		N/A		Gutter X Slope (%)		N/A			
				N/A		Painted X Walk1?		No				Road Slope (%)		0.6			
						X Walk 1 Direction		To S				Road X Slope (%)		4.7

X Walk 1 Width (in)		N/A				Clear Space?		N/A			
						X Walk 1 Slope (%)		0.6		N/A		Clear Space to XWalk (in)		N/A			
						X Walk 1 X Slope (%)		4.7		N/A		Storm Grate/Utility Hazard?		N/A			
				N/A		Ramp inside XWalk1?		N/A				Storm Grate/Utility Type					
				N/A		Any Obstructions?		N/A						N/A			
						Obstruction Type				Yes		Surface Condition? (G/P)		Good			
										N/A		N/A		Curb Slope (%)		1.3
