Access Compliance Report

Public Rights-of-Way

(Curb Ramps)

Intersection ID: 13301	Main Street: S_TRYON_ST	Cross Street: W_CATHERINE_ST	Location: NW
ADA ID: 370CF3E54E10	Ramp Type: BlendTrans2	Initial Pass/Fail: Fail	Overall Compliance: No
Codes/Mitigation Info/Possible Solution		Field Measurements/Component Compliance	
Severity Score: 17.5

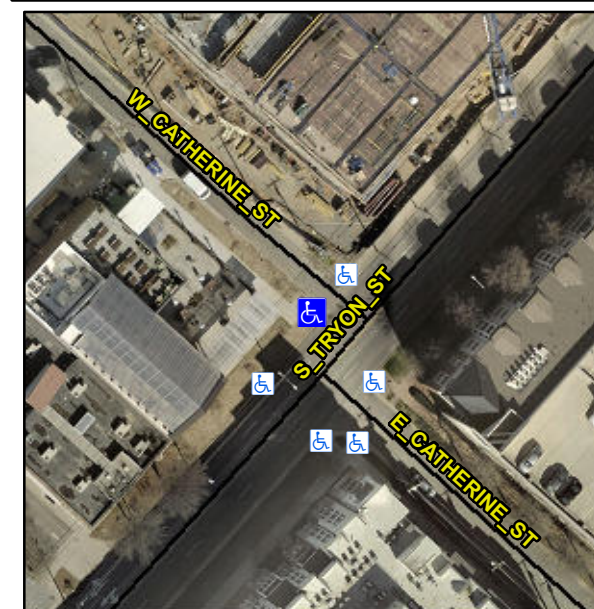
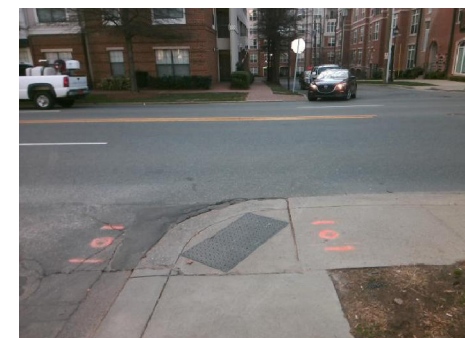
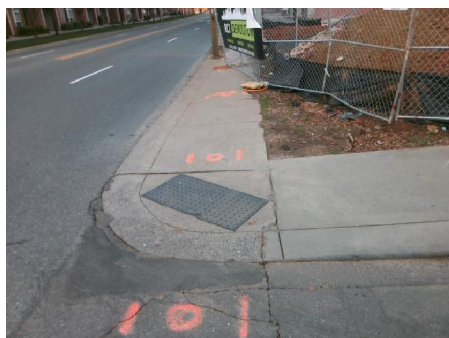
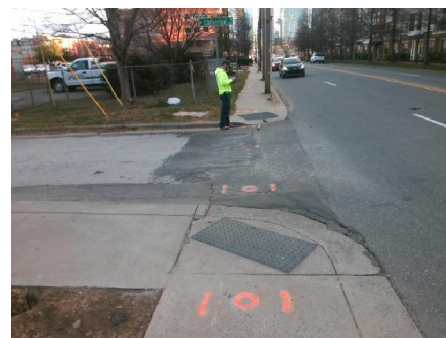
Not Found, R304.5.1

Compliance	Description	Data	Compliance	Description	Data
N/A	Ramp Length (in)	57.0	Yes	BlendTrans Slope (%)	2.3
No	Ramp Width (in)	33.0	Yes	BlendTrans XSlope (%)	1.2
N/A	Flare Type LT	N/A	N/A	Flare Type RT	N/A
N/A	Flare Slope LT (%)	N/A	N/A	Flare Slope RT (%)	N/A
N/A	Flare Traversable LT?	N/A	N/A	Flare Traversable RT?	N/A
N/A	Landing Length (in)	N/A	N/A	DWS Provided?	N/A
N/A	Landing Width (in)	N/A	N/A	DWS Contrast?	N/A
N/A	Landing Slope (%)	N/A	N/A	DWS Length (in)	N/A
N/A	Landing X Slope (%)	N/A	N/A	DWS Full Width?	N/A
N/A	Landing Curb? (Y/N)	N/A	N/A	DWS Offset (in)	N/A
N/A	Shared Landing?	N/A			
N/A	Gutter Ponding?	N/A	N/A	Gutter Slope (%)	N/A
N/A	Gutter Lip Ht (in)	N/A	N/A	Gutter X Slope (%)	N/A
N/A	Painted X Walk1?	No	N/A	Painted X Walk2?	No
	X Walk 1 Direction	To SE		X Walk 2 Direction	To NE
	X Walk 1 Width (in)	N/A		X Walk 2 Width (in)	N/A
	X Walk 1 Slope (%)	5.0		X Walk 2 Slope (%)	4.9
	X Walk 1 X Slope (%)	2.4		X Walk 2 X Slope (%)	1.1

N/A	Ramp inside XWalk1?	N/A	N/A	Ramp inside XWalk2?	N/A
	Road Slope (%)	5.0		Clear Space?	N/A
	Road X Slope (%)	1.9	N/A	Clear Space to XWalk (in)	N/A
N/A	Any Obstructions?	N/A	N/A	Storm Grate/Utility Hazard?	N/A
	Obstruction Type			Storm Grate/Utility Type	
		N/A			N/A
			Yes	Surface Condition? (G/P)	Good
			No	Curb Slope (%)	6.1

Remove & Replace Curb Ramp With Two New Directional Ramps or Equivalent.
