# Access Compliance Report

## Public Rights-of-Way

### (Curb Ramps)

Intersection ID: N/A	Main Street: EASTWAY_DR	Cross Street: N/A	Location: E
ADA ID: 370F2B24F6FE	Ramp Type: MedianPerp	Initial Pass/Fail: Fail	Overall Compliance: No
		Severity Score: 10

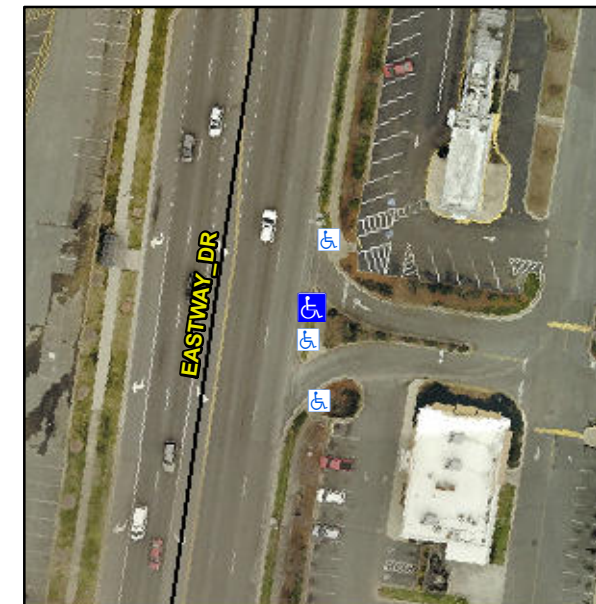
**Not Found, R304.5.1, R304.5.3**

Compliance	Description	Data	Compliance	Description	Data
N/A	Ramp Length (in)	57.0	Yes	Ramp Slope (%)	5.3
No	Ramp Width (in)	41.0	No	Ramp XSlope (%)	3.0
N/A	Flare Type LT	N/A	N/A	Flare Type RT	N/A
N/A	Flare Slope LT (%)	N/A	N/A	Flare Slope RT (%)	N/A
N/A	Flare Traversable LT?	N/A	N/A	Flare Traversable RT?	N/A
N/A	Landing Length (in)	N/A	N/A	DWS Provided?	N/A
N/A	Landing Width (in)	N/A	N/A	DWS Contrast?	N/A
N/A	Landing Slope (%)	N/A	N/A	DWS Length (in)	N/A
N/A	Landing X Slope (%)	N/A	N/A	DWS Full Width?	N/A
N/A	Landing Curb? (Y/N)	N/A	N/A	DWS Offset (in)	N/A
N/A	Shared Landing?	N/A			
N/A	Gutter Ponding?	N/A	N/A	Gutter Slope (%)	N/A
N/A	Gutter Lip Ht (in)	N/A	N/A	Gutter X Slope (%)	N/A
N/A	Painted X Walk1?	No	N/A	Painted X Walk2?	N/A
	X Walk 1 Direction	To N		X Walk 2 Direction	N/A
N/A	X Walk 1 Width (in)	N/A	N/A	X Walk 2 Width (in)	N/A
	X Walk 1 Slope (%)	8.2		X Walk 2 Slope (%)	N/A
	X Walk 1 X Slope (%)	0.1		X Walk 2 X Slope (%)	N/A

N/A	Ramp inside XWalk1?	N/A	N/A	Ramp inside XWalk2?	N/A
	Road Slope (%)	N/A	N/A	Clear Space?	N/A
	Road X Slope (%)	N/A	N/A	Clear Space to XWalk (in)	N/A
N/A	Any Obstructions?	N/A	N/A	Storm Grate/Utility Hazard?	N/A
	Obstruction Type			Storm Grate/Utility Type	
		N/A			N/A
			Yes	Surface Condition? (G/P)	Good

**Remove & Replace Entire Ramp.**
