Access Compliance Report

Public Rights-of-Way

(Curb Ramps)

| Intersection ID: 27189 | Main Street: MCKEE_RD | Cross Street: PROVIDENCE_ARBOURS_DR | Location: NW |

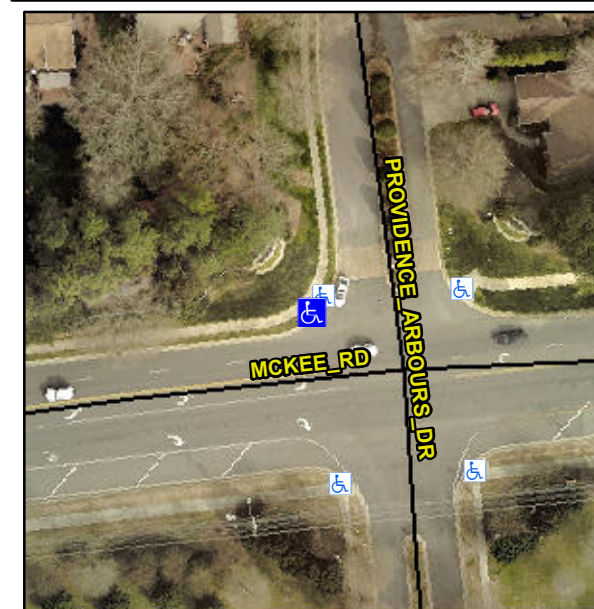
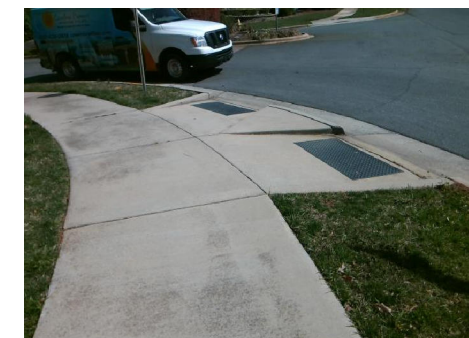
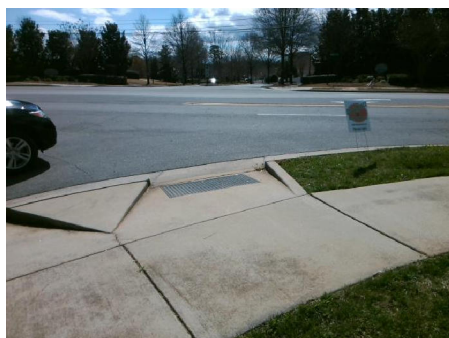
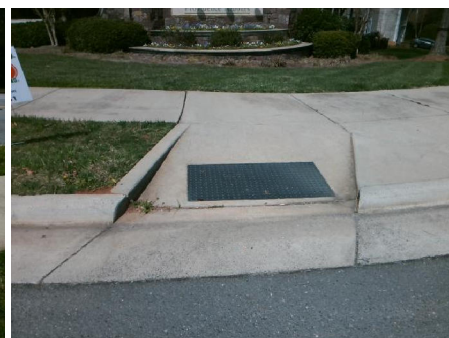
| ADA ID: 3717669D754C | Ramp Type: Perp | Initial Pass/Fail: Fail | Overall Compliance: No |

R304.2.2, R304.5.3

| Compliance | Description | Data | Compliance | Description | Data |
|---|---|---|---|---|---|
| N/A | Ramp Length (in) | 66.5 | No | Ramp Slope (%) | 9.7 |
| Yes | Ramp Width (in) | 71.0 | No | Ramp XSlope (%) | 3.0 |

Remove & Replace Entire Ramp.
