# Access Compliance Report

## Public Rights-of-Way

| Intersection ID: 45505 | Main Street: GINHOUSE_LN | Cross Street: MEADOW_BOTTOM_RD | Location: SW |
| ADA ID: 371830A4AB44 | Ramp Type: PerpDiag | Initial Pass/Fail: Fail | Overall Compliance: No |

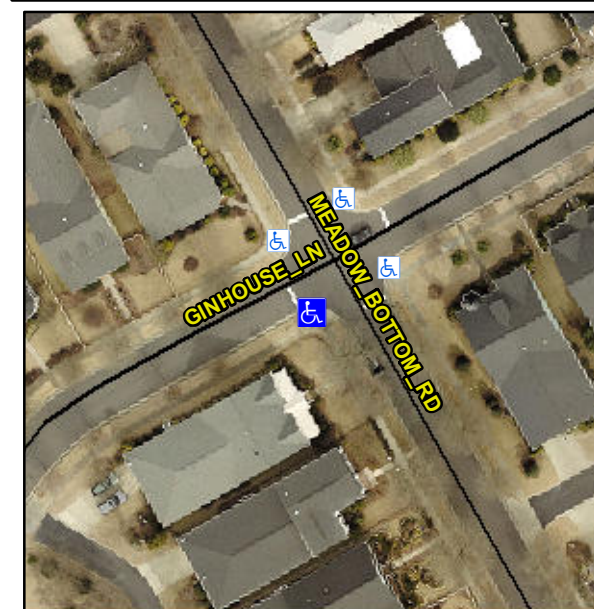
| Severity Score: 8.75 | | | |

**Not Found, R304.5.1**

| Compliance | Description | Data | Compliance | Description | Data |
|---|---|---|---|---|---|
| No | Ramp Width (in) | 37.0 | Yes | Ramp XSlope (%) | 0.1 |

**Remove & Replace Curb Ramp With Two New Directional Ramps or Equivalent.**

Total Cost: \$ 3200.00

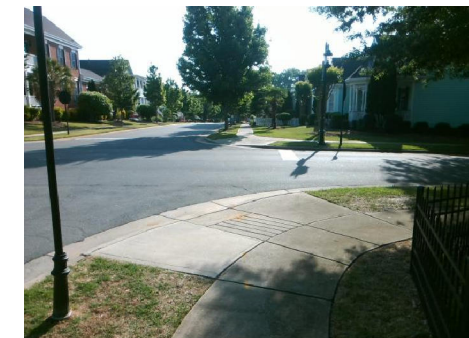
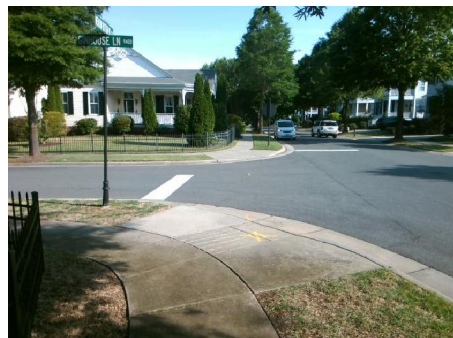
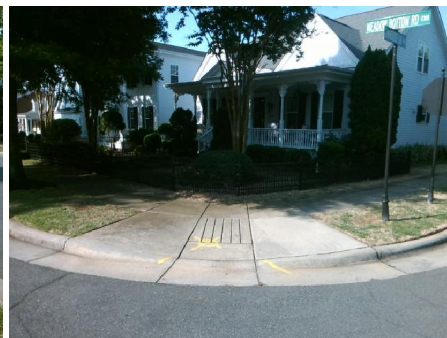
| Compliance | Description | Data | Compliance | Description | Data |
|---|---|---|---|---|---|
| | | | Yes | Surface Condition? (G/P) | Good |
