# Access Compliance Report

## Public Rights-of-Way

### (Curb Ramps)

Intersection ID: 13149	Main Street: CENTRAL_AV	Cross Street: THE_PLAZA	Location: SE
ADA ID: 371CE32E4AF7	Ramp Type: Perp	Initial Pass/Fail: Fail	Overall Compliance: No
			Severity Score: 8.75
Codes/Mitigation Info/Possible Solution		Field Measurements/Component Compliance

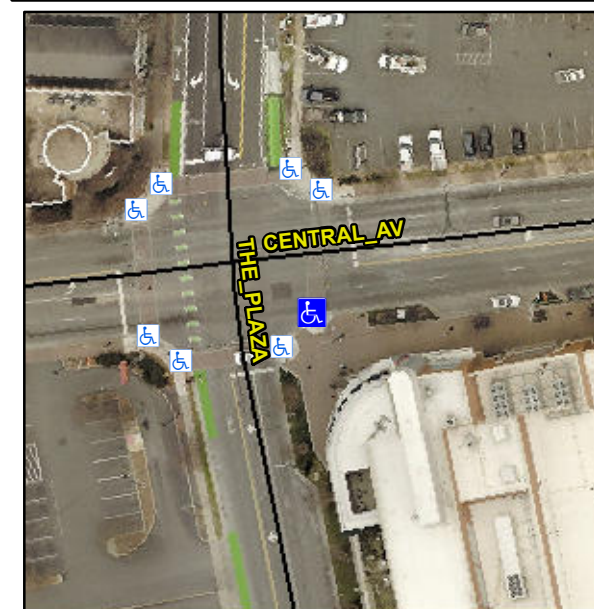
**Not Found, R304.5.1**

Compliance	Description	Data	Compliance	Description	Data
N/A	Ramp Length (in)	52.0	Yes	Ramp Slope (%)	6.3
No	Ramp Width (in)	47.0	Yes	Ramp XSlope (%)	0.5
N/A	Flare Type LT	N/A	N/A	Flare Type RT	N/A
N/A	Flare Slope LT (%)	N/A	N/A	Flare Slope RT (%)	N/A
N/A	Flare Traversable LT?	N/A	N/A	Flare Traversable RT?	N/A
N/A	Landing Length (in)	N/A	N/A	DWS Provided?	N/A
N/A	Landing Width (in)	N/A	N/A	DWS Contrast?	N/A
N/A	Landing Slope (%)	N/A	N/A	DWS Length (in)	N/A
N/A	Landing X Slope (%)	N/A	N/A	DWS Full Width?	N/A
N/A	Landing Curb? (Y/N)	N/A	N/A	DWS Offset (in)	N/A
N/A	Shared Landing?	N/A			
N/A	Gutter Ponding?	N/A	N/A	Gutter Slope (%)	N/A
N/A	Gutter Lip Ht (in)	N/A	N/A	Gutter X Slope (%)	N/A
N/A	Painted X Walk1?	Yes	N/A	Painted X Walk2?	N/A
	X Walk 1 Direction	To N		X Walk 2 Direction	N/A
N/A	X Walk 1 Width (in)	96.0	N/A	X Walk 2 Width (in)	N/A
	X Walk 1 Slope (%)	2.1		X Walk 2 Slope (%)	N/A
	X Walk 1 X Slope (%)	2.8		X Walk 2 X Slope (%)	N/A

N/A	Ramp inside XWalk1?	Yes	N/A	Ramp inside XWalk2?	N/A
	Road Slope (%)	N/A	N/A	Clear Space?	N/A
	Road X Slope (%)	N/A	N/A	Clear Space to XWalk (in)	N/A
N/A	Any Obstructions?	N/A	N/A	Storm Grate/Utility Hazard?	N/A
	Obstruction Type			Storm Grate/Utility Type	
		N/A			N/A
		Yes		Surface Condition? (G/P)	Good

**Remove & Replace Entire Ramp.**

Total Cost: \$ 1850.00
