## Access Compliance Report Public Rights-of-Way (Curb Ramps)

Intersection ID: 48453Main Street: ALVARADO\_WYCross Street: RED\_RUST\_LNLocation:NEADA ID: 37214E9EDB21Ramp Type: PerpInitial Pass/Fail: FailOverall Compliance: NoSeverity Score: 21.25

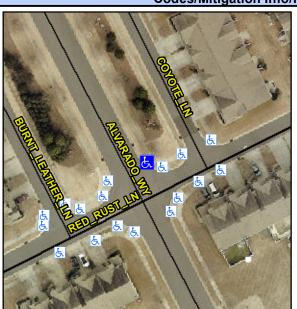
Field Measurements/Component Compliance								
Comp	liance Description	Data	Comp	liance Description	Data			
N/A	Ramp Length (in)	72.0	No	Ramp Slope (%)	10.2			
No	Ramp Width (in)	38.0	Yes	Ramp XSlope (%)	0.6			
N/A	Flare Type LT	N/A	N/A	Flare Type RT	N/A			
N/A	Flare Slope LT (%)	N/A	N/A	Flare Slope RT (%)	N/A			
N/A	Flare Traversable LT?	N/A	N/A	Flare Traversable RT?	N/A			
N/A	Landing Length (in)	N/A	N/A	DWS Provided?	N/A			
N/A	Landing Width (in)	N/A	N/A	DWS Contrast?	N/A			
N/A	Landing Slope (%)	N/A	N/A	DWS Length (in)	N/A			
N/A	Landing X Slope (%)	N/A	N/A	DWS Full Width?	N/A			
N/A	Landing Curb? (Y/N)	N/A	N/A	DWS Offset (in)	N/A			
N/A	Shared Landing?	N/A						
N/A	Gutter Ponding?	N/A	N/A	Gutter Slope (%)	N/A			
N/A	Gutter Lip Ht (in)	N/A	N/A	Gutter X Slope (%)	N/A			
N/A	Painted X Walk1?	No	N/A	Painted X Walk2?	N/A			
	X Walk 1 Direction	To SW		X Walk 2 Direction	N/A			
N/A	X Walk 1 Width (in)	N/A	N/A	X Walk 2 Width (in)	N/A

X Walk 1 Slope (%)	2.8		X Walk 2 Slope (%)	N/A			
	X Walk 1 X Slope (%)	4.6		X Walk 2 X Slope (%)	N/A			
N/A	Ramp inside XWalk1?	N/A	N/A	Ramp inside XWalk2?	N/A			
	Road Slope (%)	N/A	N/A	Clear Space?	N/A			
	Road X Slope (%)	N/A	N/A	Clear Space to XWalk (in)	N/A			
N/A	Any Obstructions?	N/A	N/A	Storm Grate/Utility Hazard?	N/A			
	Obstruction Type			Storm Grate/Utility Type				
		N/A			N/A			
			Yes	Surface Condition? (G/P)	Good			
197	. 00000

Possible Solutions:
Remove & Replace Entire Ramp.
Surveyor Notes:
N/A
PROW/ADA:
Not Found, R304.5.1, R304.2.2
J
