# Access Compliance Report

## Public Rights-of-Way

### (Curb Ramps)

Intersection ID: 13787	Main Street: CHARLOTTETOWNE_AV	Cross Street: E_4TH_ST	Location:	S
ADA ID: 3737BD26D940	Ramp Type: PerpDiag	Initial Pass/Fail: Fail	Overall Compliance: No	Severity Score: 12.5
Codes/Mitigation Info/Possible Solution		Field Measurements/Component Compliance

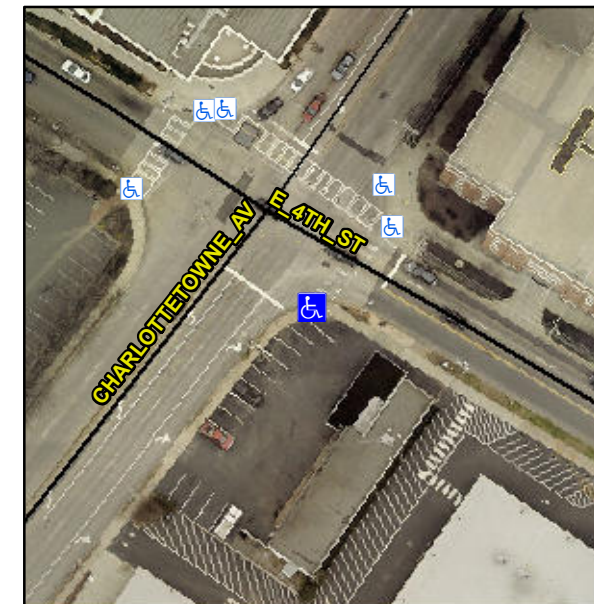
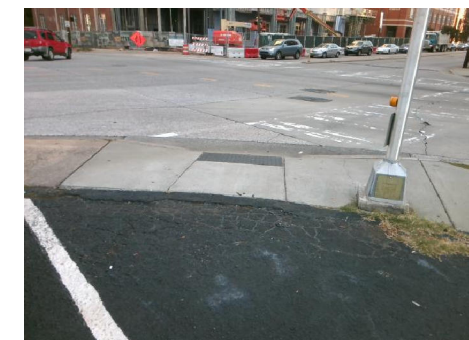
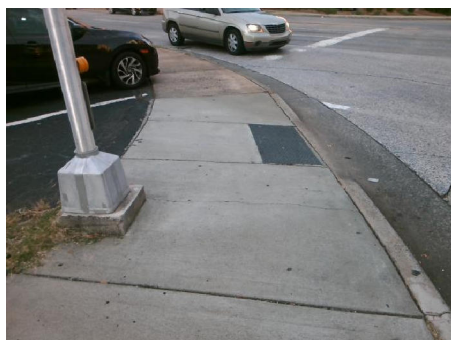
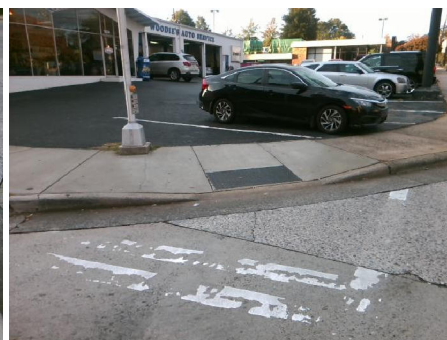
**Not Found, R304.2.2**

Compliance	Description	Data	Compliance	Description	Data
N/A	Ramp Length (in)	76.5	No	Ramp Slope (%)	11.6
Yes	Ramp Width (in)	48.0	Yes	Ramp XSlope (%)	1.1
N/A	Flare Type LT	N/A	N/A	Flare Type RT	N/A
N/A	Flare Slope LT (%)	N/A	N/A	Flare Slope RT (%)	N/A
N/A	Flare Traversable LT?	N/A	N/A	Flare Traversable RT?	N/A
N/A	Landing Length (in)	N/A	N/A	DWS Provided?	N/A
N/A	Landing Width (in)	N/A	N/A	DWS Contrast?	N/A
N/A	Landing Slope (%)	N/A	N/A	DWS Length (in)	N/A
N/A	Landing X Slope (%)	N/A	N/A	DWS Full Width?	N/A
N/A	Landing Curb? (Y/N)	N/A	N/A	DWS Offset (in)	N/A
N/A	Shared Landing?	N/A			
N/A	Gutter Ponding?	N/A	N/A	Gutter Slope (%)	N/A
N/A	Gutter Lip Ht (in)	N/A	N/A	Gutter X Slope (%)	N/A
N/A	Painted X Walk1?	Yes	N/A	Painted X Walk2?	No
	X Walk 1 Direction	To NE		X Walk 2 Direction	To NW
N/A	X Walk 1 Width (in)	106.0	N/A	X Walk 2 Width (in)	N/A
	X Walk 1 Slope (%)	1.2		X Walk 2 Slope (%)	1.1
	X Walk 1 X Slope (%)	0.1		X Walk 2 X Slope (%)	1.9

N/A	Ramp inside XWalk1?	Yes	N/A	Ramp inside XWalk2?	N/A
	Road Slope (%)	1.2	N/A	Clear Space?	N/A
	Road X Slope (%)	1.9	N/A	Clear Space to XWalk (in)	N/A
N/A	Any Obstructions?	N/A	N/A	Storm Grate/Utility Hazard?	N/A
	Obstruction Type			Storm Grate/Utility Type	
		N/A			N/A
			Yes	Surface Condition? (G/P)	Good

**Remove & Replace Curb Ramp With Two New Directional Ramps or Equivalent.**

Total Cost: \$ 3200.00
