# Access Compliance Report

## Public Rights-of-Way

| Intersection ID: 52893 | Main Street: TWITTER_LN | Cross Street: SANCTUARY_PL | Location: NE |
| ADA ID: 373A5136448E | Ramp Type: PerpDiag | Initial Pass/Fail: Fail | Overall Compliance: No |

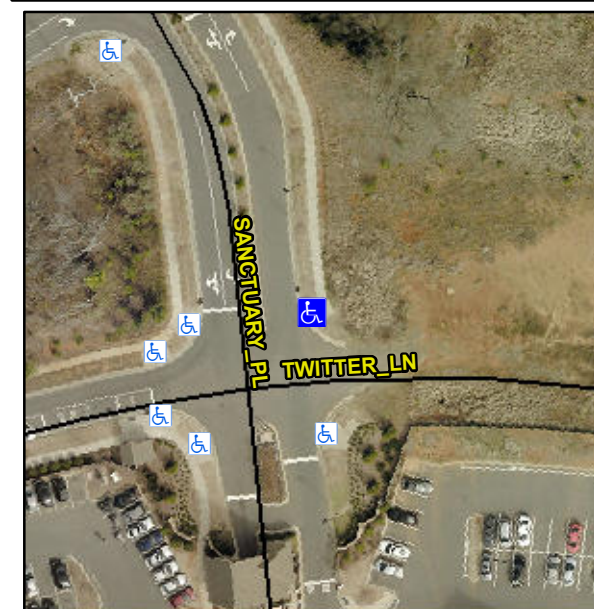
| Severity Score: 12.5 | | | |

**Not Found, R304.5.3**

| Compliance | Description | Data | Compliance | Description | Data |
|---|---|---|---|---|---|
| N/A | Ramp Length (in) | 95.5 | Yes | Ramp Slope (%) | 8.2 |
| Yes | Ramp Width (in) | 48.0 | No | Ramp XSlope (%) | 5.7 |

**Remove & Replace Curb Ramp With Two New Directional Ramps or Equivalent.**

Total Cost: \$ 3200.00
