Access Compliance Report

Public Rights-of-Way

(Curb Ramps)

Intersection ID: N/A	Main Street: INDEPENDENCE_RD	Cross Street: N/A	Location: NW
ADA ID: 37440259BE49	Ramp Type: Directional1	Initial Pass/Fail: Fail	Overall Compliance: No
		Severity Score: 12.5

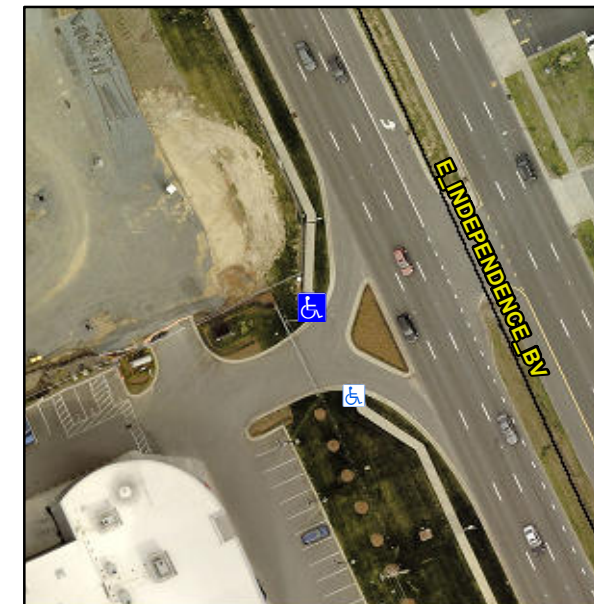
Compliance	Description	Data	Compliance	Description	Data
N/A	Ramp Length (in)	100.0	N/A	Grade Break?	N/A
Yes	Ramp Width (in)	67.0	N/A	Grade Break Slope (%)	0.0
No	Ramp Slope (%)	10.4	N/A	Grade Break XSlope (%)	0.0
Yes	Ramp XSlope (%)	0.7			
N/A	Flare Type LT	N/A	N/A	Flare Type RT	N/A
N/A	Flare Slope LT (%)	N/A	N/A	Flare Slope RT (%)	0.0
N/A	Flare Traversable LT?	N/A	N/A	Flare Traversable RT?	N/A
N/A	Landing Length (in)	0.0	N/A	DWS Provided?	N/A
N/A	Landing Width (in)	0.0	N/A	DWS Contrast?	N/A
N/A	Landing Slope (%)	0.0	N/A	DWS Length (in)	N/A
N/A	Landing X Slope (%)	0.0	N/A	DWS Full Width?	N/A
N/A	Landing Curb? (Y/N)	N/A	N/A	DWS Offset LT (in)	N/A
N/A	Shared Landing?	N/A	N/A	DWS Offset RT (in)	N/A
N/A	Gutter Ponding?	Yes	N/A	Gutter Slope (%)	N/A
N/A	Gutter Lip Ht (in)	0.0	N/A	Gutter X Slope (%)	N/A
N/A	Painted X Walk1?	No		Road Slope (%)	4.4
	X Walk 1 Direction	To S		Road X Slope (%)	4.4
	X Walk 1 Width (in)	N/A		Clear Space?	N/A

X Walk 1 Slope (%)	4.4	N/A	Clear Space to XWalk (in)	N/A
	X Walk 1 X Slope (%)	4.4	N/A	Storm Grate/Utility Hazard?	N/A
N/A	Ramp inside XWalk1?	N/A		Storm Grate/Utility Type	
N/A	Any Obstructions?	N/A			N/A
	Obstruction Type		Yes	Surface Condition? (G/P)	Good
			N/A	Curb Slope (%)	12.9

Remove & Replace Entire Ramp.
