# Access Compliance Report

## Public Rights-of-Way

### (Curb Ramps)

Intersection ID: 28166	Main Street: FLAT_CREEK_DR	Cross Street: WAGON WHEEL_CT	Location: NW
ADA ID: 37476DFE7434	Ramp Type: BlendTrans1	Initial Pass/Fail: Pass	Overall Compliance: No
Severity Score: 15			
Codes/Mitigation Info/Possible Solution		Field Measurements/Component Compliance

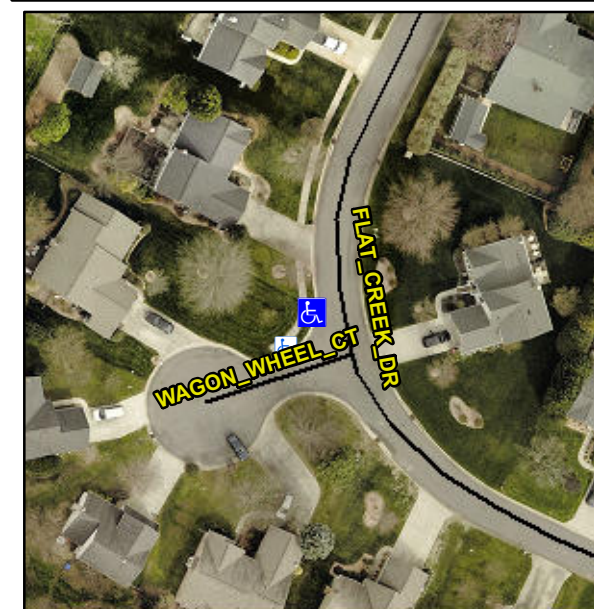
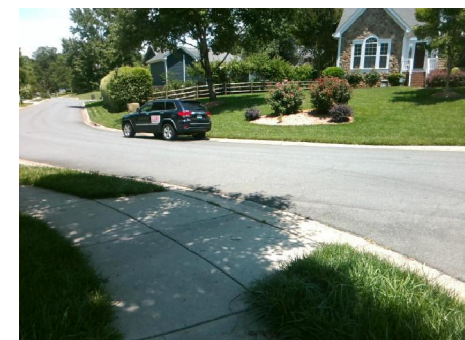
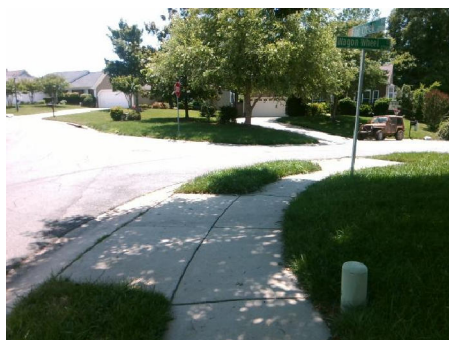
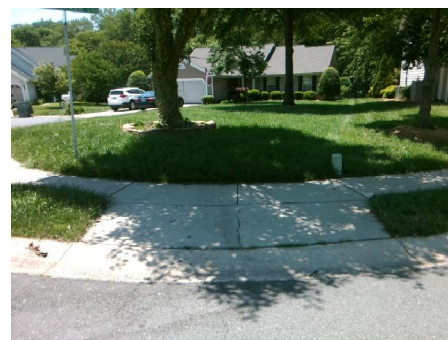
**Not Found, R304.2.1, R304.2.2-Perp, R304.3.2-Para, R305, R304.5.4**

Compliance	Description	Data	Compliance	Description	Data
N/A	Ramp Length (in)	51.5	Yes	BlendTrans Slope (%)	3.5
Yes	Ramp Width (in)	48.0	Yes	BlendTrans XSlope (%)	0.8
N/A	Flare Type LT	Sloped	N/A	Flare Type RT	Sloped
N/A	Flare Slope LT (%)	8.0	N/A	Flare Slope RT (%)	0.4
N/A	Flare Traversable LT?	No	N/A	Flare Traversable RT?	No
No	Landing Length (in)	42.0	No	DWS Provided?	No
Yes	Landing Width (in)	48.0	N/A	DWS Contrast?	No
No	Landing Slope (%)	3.3	N/A	DWS Length (in)	N/A
Yes	Landing X Slope (%)	1.7	N/A	DWS Full Width?	No
N/A	Landing Curb? (Y/N)	No	N/A	DWS Offset (in)	N/A
N/A	Shared Landing?	No			
Yes	Gutter Ponding?	No	No	Gutter Slope (%)	7.5
Yes	Gutter Lip Ht (in)	0.0	Yes	Gutter X Slope (%)	3.8
N/A	Painted X Walk1?	No	N/A	Painted X Walk2?	N/A
	X Walk 1 Direction	To NE		X Walk 2 Direction	N/A
	X Walk 1 Width (in)	N/A		X Walk 2 Width (in)	N/A
	X Walk 1 Slope (%)	3.1		X Walk 2 Slope (%)	N/A
	X Walk 1 X Slope (%)	5.0		X Walk 2 X Slope (%)	N/A

N/A	Ramp inside XWalk1?	N/A	N/A	Ramp inside XWalk2?	N/A
	Road Slope (%)	5.0		Clear Space?	Yes
	Road X Slope (%)	3.1	N/A	Clear Space to XWalk (in)	N/A
Yes	Any Obstructions?	No	Yes	Storm Grate/Utility Hazard?	No
	Obstruction Type			Storm Grate/Utility Type	
		N/A			N/A
			Yes	Surface Condition? (G/P)	Good
			No	Curb Slope (%)	19.3

**Remove & Replace Curb Ramp With Two New Directional Ramps or Equivalent. Remove & Replace Gutter.**
