Access Compliance Report

Public Rights-of-Way

(Curb Ramps)

Intersection ID: 31418	Main Street: CHEVIOTT_HILL_LN	Cross Street: GUILDHALL_LN	Location: SW
ADA ID: 37496AACD678	Ramp Type: PerpDiag	Initial Pass/Fail: Fail	Overall Compliance: No
Severity Score: 46.25			
Codes/Mitigation Info/Possible Solution		Field Measurements/Component Compliance

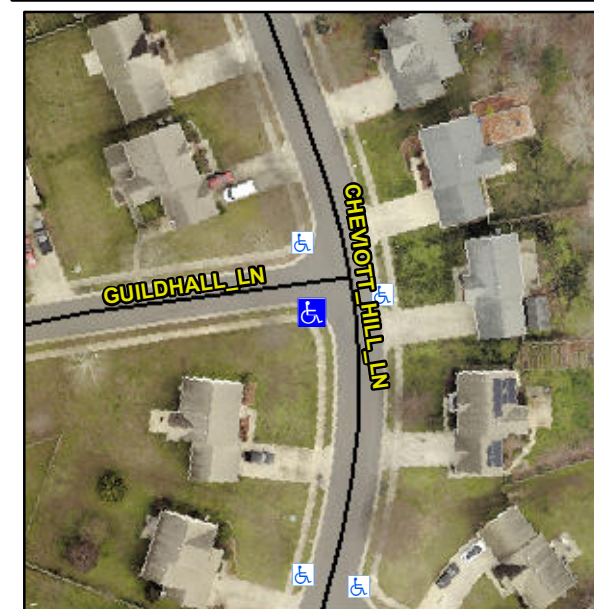
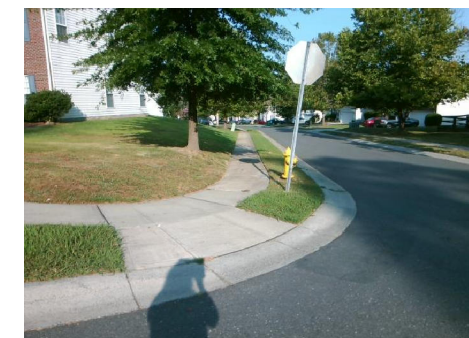
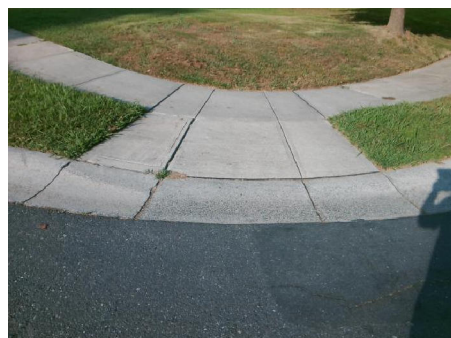
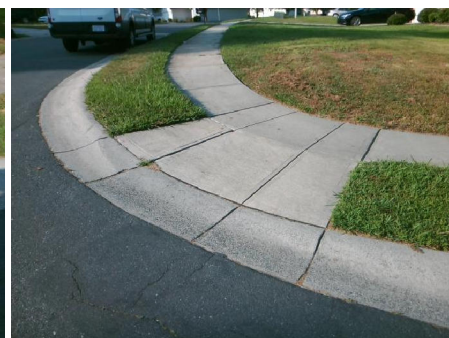
R304.5.1, R304.2.2, R304.5.3

Compliance	Description	Data	Compliance	Description	Data
N/A	Ramp Length (in)	47.0	No	Ramp Slope (%)	9.5
No	Ramp Width (in)	37.5	No	Ramp XSlope (%)	8.5
N/A	Flare Type LT	N/A	N/A	Flare Type RT	N/A
N/A	Flare Slope LT (%)	N/A	N/A	Flare Slope RT (%)	N/A
N/A	Flare Traversable LT?	N/A	N/A	Flare Traversable RT?	N/A
N/A	Landing Length (in)	N/A	N/A	DWS Provided?	N/A
N/A	Landing Width (in)	N/A	N/A	DWS Contrast?	N/A
N/A	Landing Slope (%)	N/A	N/A	DWS Length (in)	N/A
N/A	Landing X Slope (%)	N/A	N/A	DWS Full Width?	N/A
N/A	Landing Curb? (Y/N)	N/A	N/A	DWS Offset (in)	N/A
N/A	Shared Landing?	N/A			
N/A	Gutter Ponding?	N/A	N/A	Gutter Slope (%)	N/A
N/A	Gutter Lip Ht (in)	N/A	N/A	Gutter X Slope (%)	N/A
N/A	Painted X Walk1?	No	N/A	Painted X Walk2?	No
	X Walk 1 Direction	To E		X Walk 2 Direction	To N
N/A	X Walk 1 Width (in)	N/A	N/A	X Walk 2 Width (in)	N/A
	X Walk 1 Slope (%)	7.8		X Walk 2 Slope (%)	2.7
	X Walk 1 X Slope (%)	3.4		X Walk 2 X Slope (%)	8.9

N/A	Ramp inside XWalk1?	N/A	N/A	Ramp inside XWalk2?	N/A
	Road Slope (%)	6.6	N/A	Clear Space?	N/A
	Road X Slope (%)	6.9	N/A	Clear Space to XWalk (in)	N/A
N/A	Any Obstructions?	N/A	N/A	Storm Grate/Utility Hazard?	N/A
	Obstruction Type			Storm Grate/Utility Type	
		N/A			N/A
			Yes	Surface Condition? (G/P)	Good

Remove & Replace Curb Ramp With Two New Directional Ramps or Equivalent.
