Access Compliance Report

Public Rights-of-Way

(Curb Ramps)

| Intersection ID: 29752 | Main Street: ARMORCREST_LN | Cross Street: KNIGHT_CASTLE_DR | Location: NE |

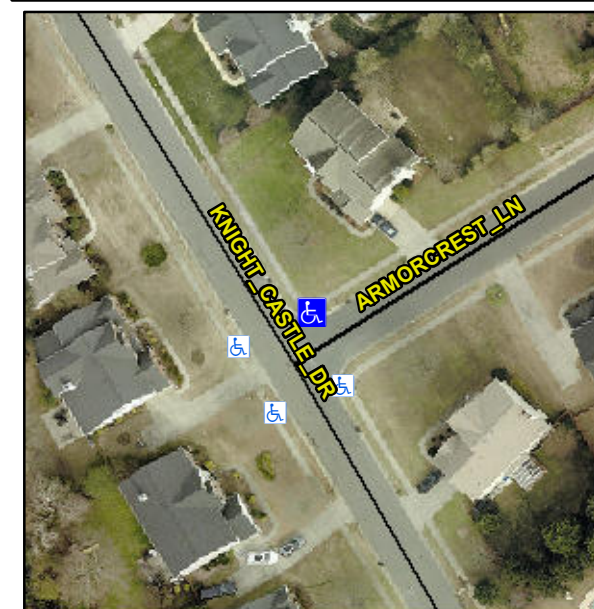
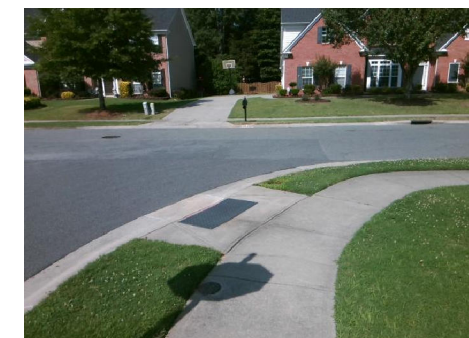
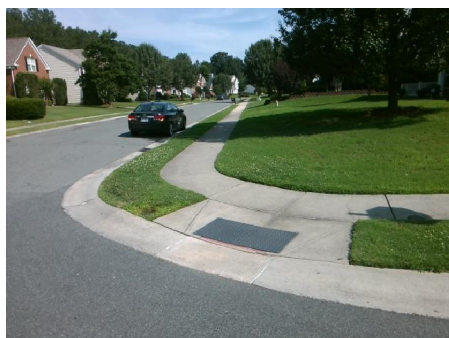
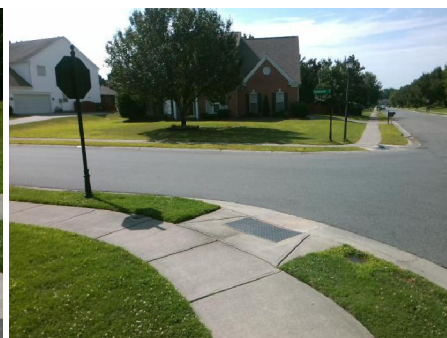
| ADA ID: 374A7F85305E | Ramp Type: PerpDiag | Initial Pass/Fail: Fail | Overall Compliance: No |
| Severity Score: 33.75 | | | |

| Compliance | Description | Data | Compliance | Description | Data |
|---|---|---|---|---|---|
| N/A | Ramp Length (in) | 48.0 | No | Ramp Slope (%) | 9.1 |
| No | Ramp Width (in) | 36.0 | No | Ramp XSlope (%) | 6.5 |

Remove & Replace Curb Ramp With Two New Directional Ramps or Equivalent.

R304.5.1, R304.2.2, R304.5.3
