Access Compliance Report

Public Rights-of-Way

(Curb Ramps)

Intersection ID: 15175	Main Street: SOUTH_BV	Cross Street: POINDEXTER_DR	Location: NW
ADA ID: 376007C7B416	Ramp Type: Perp	Initial Pass/Fail: Fail	Overall Compliance: No
			Severity Score: 13.75

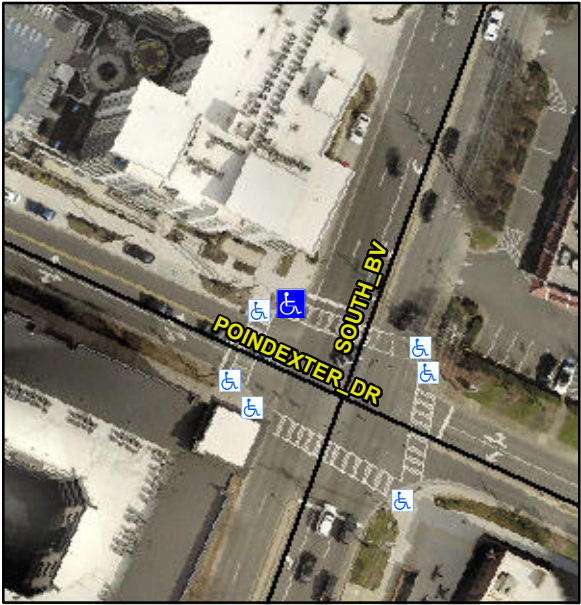
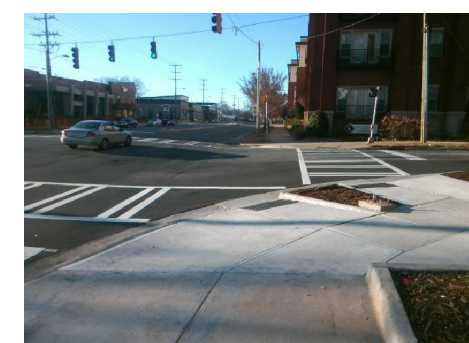
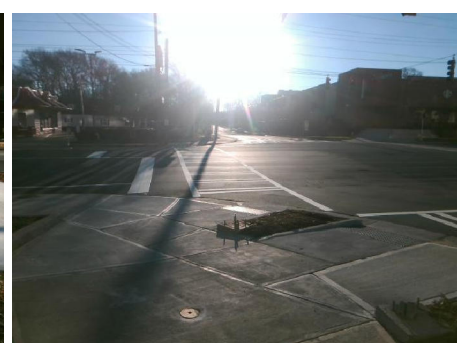
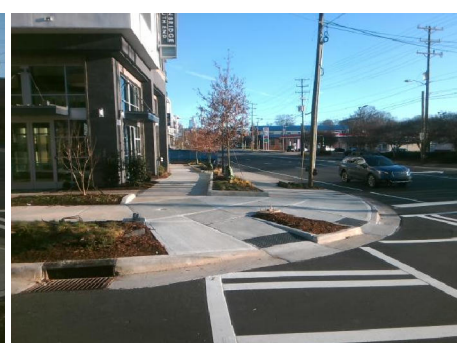
Possible Solutions:		Compliance	Description	Data
	Remove & Replace Entire Ramp.		No	Ramp Length (in)	93.0
			Yes	Ramp Width (in)	49.0
			N/A	Flare Type LT	N/A
			N/A	Flare Slope LT (%)	N/A
			N/A	Flare Traversable LT?	N/A
			N/A	Landing Length (in)	N/A
			N/A	Landing Width (in)	N/A
			N/A	Landing Slope (%)	N/A
			N/A	Landing X Slope (%)	N/A
<p>Surveyor Notes:</p> <p>N/A</p> <p>PROW/ADA:</p> <p>Not Found, R304.2.2</p>			N/A	Flare Type RT	N/A
			N/A	Flare Slope RT (%)	N/A
			N/A	Flare Traversable RT?	N/A
			N/A	DWS Provided?	N/A
			N/A	DWS Contrast?	N/A
			N/A	DWS Length (in)	N/A
			N/A	DWS Full Width?	N/A
			N/A	DWS Offset (in)	N/A
			N/A	Shared Landing?	N/A
			N/A	Gutter Ponding?	N/A
			N/A	Gutter Lip Ht (in)	N/A
			N/A	Painted X Walk1?	Yes
				X Walk 1 Direction	To SE
			N/A	X Walk 1 Width (in)	104.0
				X Walk 1 Slope (%)	1.4

X Walk 1 X Slope (%)	4.3
			N/A	Ramp inside XWalk1?	Yes
			N/A	Road Slope (%)	N/A
			N/A	Road X Slope (%)	N/A
			N/A	Any Obstructions?	N/A
				Obstruction Type	
			N/A		
			N/A		
			N/A		
			N/A		
			N/A		
			N/A		
			N/A		
			N/A		
			N/A		
Total Cost:		\$ 1850.00			
			N/A		
			Yes	Surface Condition? (G/P)	Good
