Access Compliance Report

(Curb Ramps)

| Intersection ID: 13763 | Main Street: CENTRAL_AV | Cross Street: EASTWAY_DR | Location: NE |
| ADA ID: 376C305EB00E | Ramp Type: Perp | Initial Pass/Fail: Fail | Overall Compliance: No |

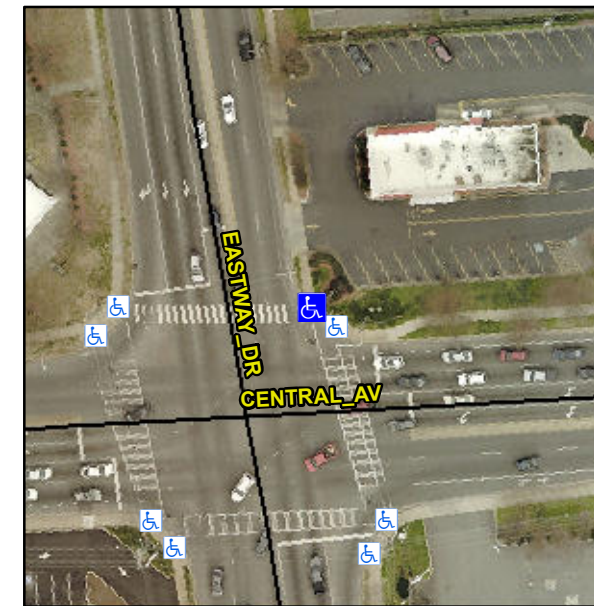
| | | Severity Score: 8.75 | |

Not Found, R304.5.1

| Compliance | Description | Data | Compliance | Description | Data |
|---|---|---|---|---|---|
| N/A | Ramp Length (in) | 71.0 | Yes | Ramp Slope (%) | 5.4 |
| No | Ramp Width (in) | 36.0 | Yes | Ramp XSlope (%) | 1.0 |

Possible Solutions:

Remove & Replace Entire Ramp.

Total Cost: \$ 1850.00

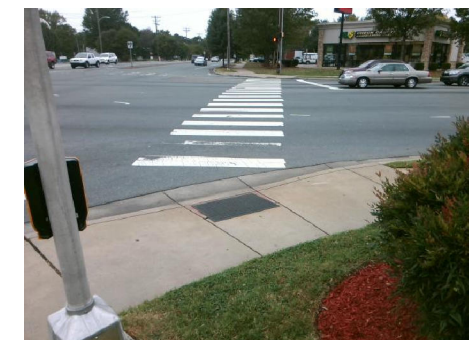
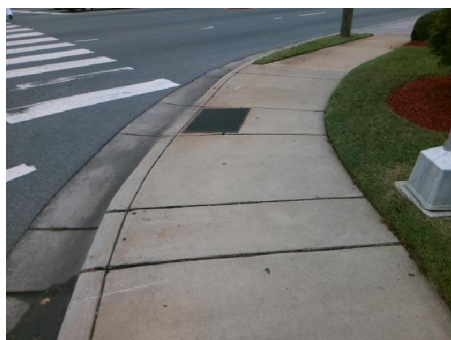
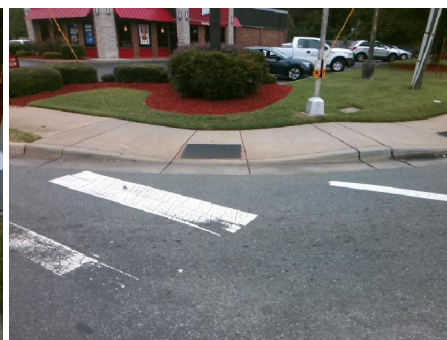
Street 1 Name EASTWAY DR
 Stop Condition-Street 2 Signal
 Street 2 Name N/A
 Stop Condition-Street 1 N/A
