Access Compliance Report

Public Rights-of-Way

(Curb Ramps)

Intersection ID: 43248	Main Street: LAMPLIGHTER_PL	Cross Street: STONEMAN_DR	Location: NE
ADA ID: 376D94B92495	Ramp Type: BlendTrans2	Initial Pass/Fail: Fail	Overall Compliance: No
Severity Score: 47.5			
Codes/Mitigation Info/Possible Solution		Field Measurements/Component Compliance

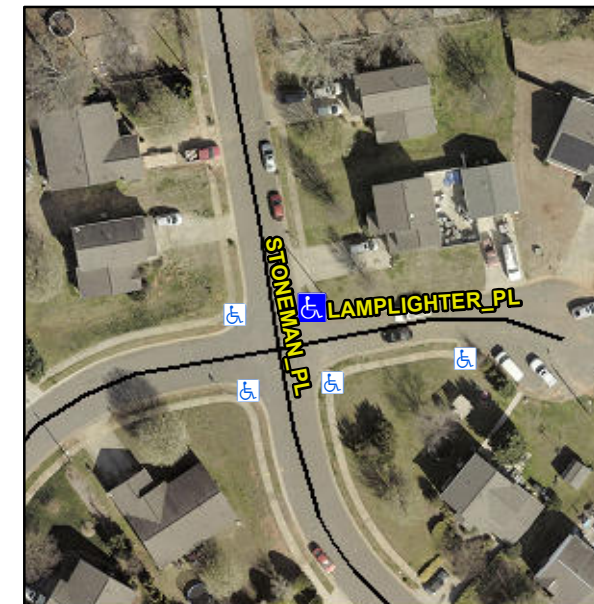
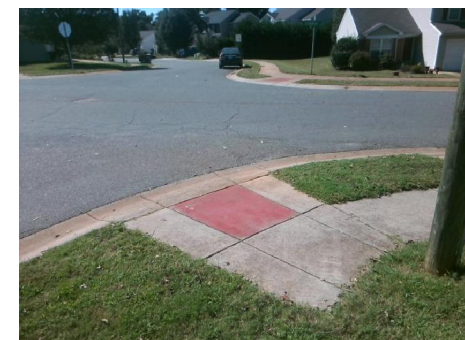
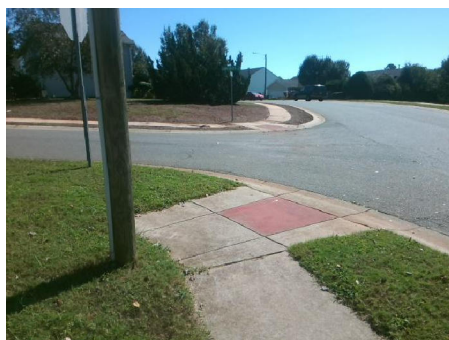
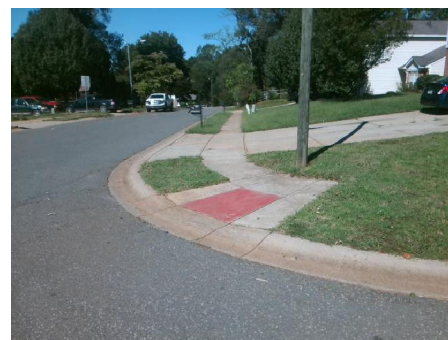
Compliance	Description	Data	Compliance	Description	Data
N/A	Ramp Length (in)	93.0	Yes	BlendTrans Slope (%)	2.8
No	Ramp Width (in)	30.0	No	BlendTrans XSlope (%)	5.7
N/A	Flare Type LT	N/A	N/A	Flare Type RT	N/A
N/A	Flare Slope LT (%)	N/A	N/A	Flare Slope RT (%)	N/A
N/A	Flare Traversable LT?	N/A	N/A	Flare Traversable RT?	N/A
N/A	Landing Length (in)	N/A	N/A	DWS Provided?	N/A
N/A	Landing Width (in)	N/A	N/A	DWS Contrast?	N/A
N/A	Landing Slope (%)	N/A	N/A	DWS Length (in)	N/A
N/A	Landing X Slope (%)	N/A	N/A	DWS Full Width?	N/A
N/A	Landing Curb? (Y/N)	N/A	N/A	DWS Offset (in)	N/A
N/A	Shared Landing?	N/A			
N/A	Gutter Ponding?	N/A	N/A	Gutter Slope (%)	N/A
N/A	Gutter Lip Ht (in)	N/A	N/A	Gutter X Slope (%)	N/A
N/A	Painted X Walk1?	No	N/A	Painted X Walk2?	No
	X Walk 1 Direction	To W		X Walk 2 Direction	To S
	X Walk 1 Width (in)	N/A		X Walk 2 Width (in)	N/A
	X Walk 1 Slope (%)	1.3		X Walk 2 Slope (%)	3.8
	X Walk 1 X Slope (%)	4.9		X Walk 2 X Slope (%)	2.3

N/A	Ramp inside XWalk1?	N/A	N/A	Ramp inside XWalk2?	N/A
	Road Slope (%)	4.8		Clear Space?	N/A
	Road X Slope (%)	2.3	N/A	Clear Space to XWalk (in)	N/A
N/A	Any Obstructions?	N/A	N/A	Storm Grate/Utility Hazard?	N/A
	Obstruction Type			Storm Grate/Utility Type	
		N/A			N/A
			Yes	Surface Condition? (G/P)	Good
			N/A	Curb Slope (%)	1.2

Possible Solutions:

Remove & Replace Curb Ramp With Two New Directional Ramps or Equivalent.
