Access Compliance Report

Public Rights-of-Way

(Curb Ramps)

Intersection ID: 5899	Main Street: CORA_ST	Cross Street: OAK_DR	Location: SE
ADA ID: 3771B5DAEB51	Ramp Type: BlendTrans2	Initial Pass/Fail: Fail	Overall Compliance: No
		Severity Score: 25

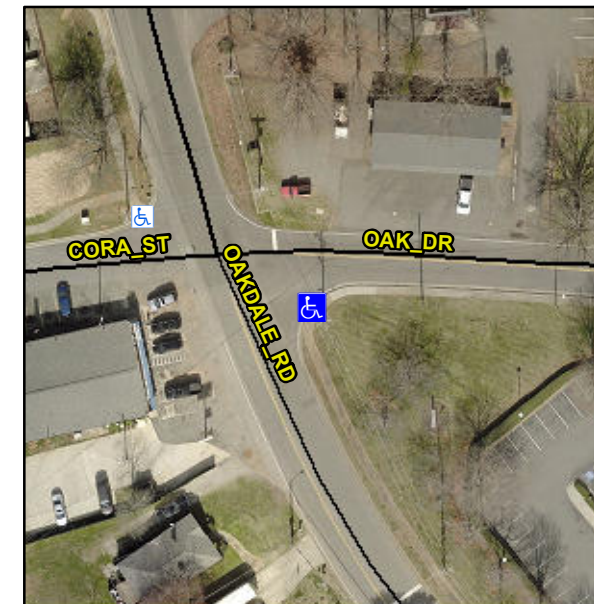
Not Found, R304.5.3

Compliance	Description	Data	Compliance	Description	Data
N/A	Ramp Length (in)	61.0	Yes	BlendTrans Slope (%)	4.2
Yes	Ramp Width (in)	76.0	No	BlendTrans XSlope (%)	13.8
N/A	Flare Type LT	N/A	N/A	Flare Type RT	N/A
N/A	Flare Slope LT (%)	N/A	N/A	Flare Slope RT (%)	N/A
N/A	Flare Traversable LT?	N/A	N/A	Flare Traversable RT?	N/A
N/A	Landing Length (in)	N/A	N/A	DWS Provided?	N/A
N/A	Landing Width (in)	N/A	N/A	DWS Contrast?	N/A
N/A	Landing Slope (%)	N/A	N/A	DWS Length (in)	N/A
N/A	Landing X Slope (%)	N/A	N/A	DWS Full Width?	N/A
N/A	Landing Curb? (Y/N)	N/A	N/A	DWS Offset (in)	N/A
N/A	Shared Landing?	N/A			
N/A	Gutter Ponding?	N/A	N/A	Gutter Slope (%)	N/A
N/A	Gutter Lip Ht (in)	N/A	N/A	Gutter X Slope (%)	N/A
N/A	Painted X Walk1?	No	N/A	Painted X Walk2?	No
	X Walk 1 Direction	To N		X Walk 2 Direction	To W
	X Walk 1 Width (in)	N/A		X Walk 2 Width (in)	N/A
	X Walk 1 Slope (%)	2.8		X Walk 2 Slope (%)	N/A
	X Walk 1 X Slope (%)	10.9		X Walk 2 X Slope (%)	N/A

N/A	Ramp inside XWalk1?	N/A	N/A	Ramp inside XWalk2?	N/A
	Road Slope (%)	10.9		Clear Space?	N/A
	Road X Slope (%)	2.8	N/A	Clear Space to XWalk (in)	N/A
N/A	Any Obstructions?	N/A	N/A	Storm Grate/Utility Hazard?	N/A
	Obstruction Type			Storm Grate/Utility Type	
		N/A			N/A
			Yes	Surface Condition? (G/P)	Good
			No	Curb Slope (%)	6.4

Remove & Replace Curb Ramp With Two New Directional Ramps or Equivalent.

Total Cost: \$ 3200.00
