# Access Compliance Report

## Public Rights-of-Way

### (Curb Ramps)

| Intersection ID: 3050 | Main Street: SIX_POINT_LN | Cross Street: HARTINGTON_PL | Location: NE |

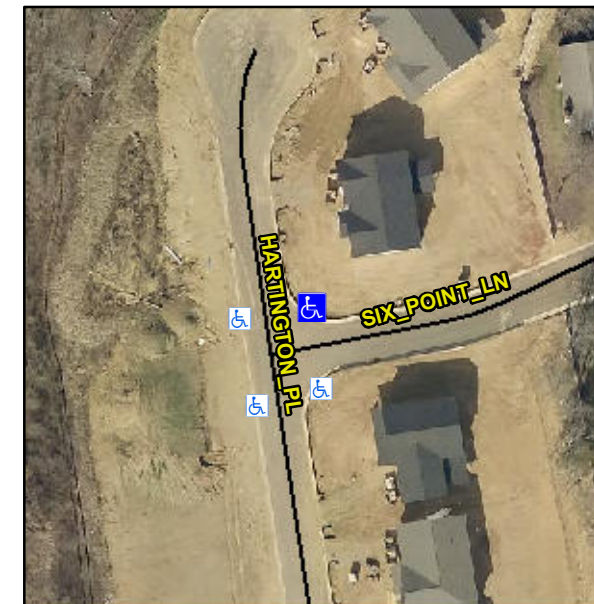
**CURB LIP 1.5, PONDING IN DWS**

**Not Found, R305.2, R304.5.4, R304.5.3**

| Compliance | Description | Data | Compliance | Description | Data |
|---|---|---|---|---|---|
| N/A | Landing Curb? (Y/N) | No | No | DWS Offset (in) | 4.7 |
| Yes | Gutter Ponding? | No | No | Gutter Slope (%) | 13.1 |
| Yes | Gutter Lip Ht (in) | 0.0 | No | Gutter X Slope (%) | 2.5 |

**Remove & Replace Curb Ramp With Two New Directional Ramps or Equivalent. Remove & Replace Gutter.**
