Access Compliance Report

Public Rights-of-Way

(Curb Ramps)

Intersection ID: 52613	Main Street: GRAHAM RIDGE DR	Cross Street: HERITAGE POND DR	Location: NW
ADA ID: 378B0499AD0E	Ramp Type: BlendTrans1	Initial Pass/Fail: Pass	Overall Compliance: No
Severity Score: 0			
Codes/Mitigation Info/Possible Solution		Field Measurements/Component Compliance

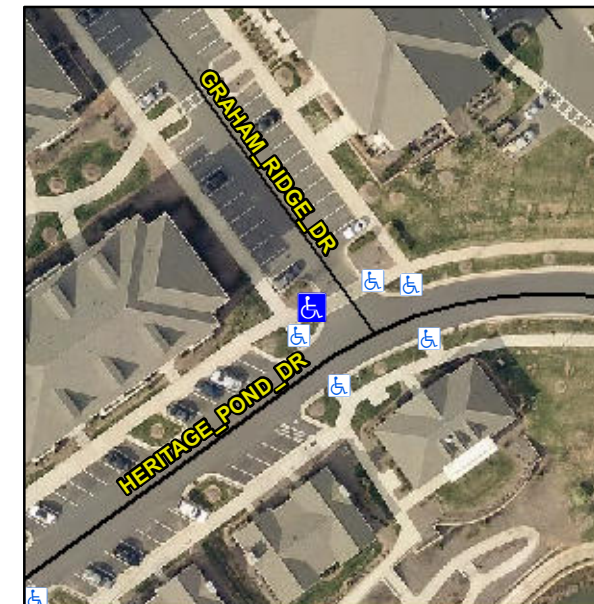
Not Found, R305.2

Compliance	Description	Data	Compliance	Description	Data
N/A	Ramp Length (in)	82.0	Yes	BlendTrans Slope (%)	1.2
Yes	Ramp Width (in)	82.0	Yes	BlendTrans XSlope (%)	1.0
Yes	Flare Type L	Curbed_NoWalkSurface	Yes	Flare Type R	Curbed_NoWalkSurface
N/A	Flare Slope LT (%)	N/A	N/A	Flare Slope RT (%)	N/A
N/A	Flare Traversable LT?	No	N/A	Flare Traversable RT?	No
Yes	Landing Length (in)	58.0	Yes	DWS Provided?	Yes
Yes	Landing Width (in)	84.0	Yes	DWS Contrast?	Yes
Yes	Landing Slope (%)	0.4	Yes	DWS Length (in)	24.0
Yes	Landing X Slope (%)	0.0	Yes	DWS Full Width?	Yes
N/A	Landing Curb? (Y/N)	No	No	DWS Offset (in)	9.0
N/A	Shared Landing?	No			
Yes	Gutter Ponding?	No	Yes	Gutter Slope (%)	1.4
Yes	Gutter Lip Ht (in)	0.0	Yes	Gutter X Slope (%)	0.7
N/A	Painted X Walk1?	Yes	N/A	Painted X Walk2?	N/A
	X Walk 1 Direction	To NE		X Walk 2 Direction	N/A
	X Walk 1 Width (in)	71.0		X Walk 2 Width (in)	N/A
	X Walk 1 Slope (%)	0.9		X Walk 2 Slope (%)	N/A

X Walk 1 X Slope (%)	1.4		X Walk 2 X Slope (%)	N/A
Yes	Ramp inside XWalk1?	Yes	N/A	Ramp inside XWalk2?	N/A
	Road Slope (%)	1.4		Clear Space?	Yes
	Road X Slope (%)	0.9	N/A	Clear Space to XWalk (in)	N/A
Yes	Any Obstructions?	No	Yes	Storm Grate/Utility Hazard?	No
	Obstruction Type			Storm Grate/Utility Type	
		N/A			N/A
			Yes	Surface Condition? (G/P)	Good
			No	Curb Slope (%)	14.1

Remove & Replace Curb Ramp With Two New Directional Ramps or Equivalent.
