Access Compliance Report

Public Rights-of-Way

(Curb Ramps)

Intersection ID: 10077	Main Street: E_35TH_ST	Cross Street: N_DAVIDSON_ST	Location: NW
ADA ID: 378DE2DEA8A5	Ramp Type: BlendTrans2	Initial Pass/Fail: Pass	Overall Compliance: No
Severity Score: 7.5			
Codes/Mitigation Info/Possible Solution		Field Measurements/Component Compliance

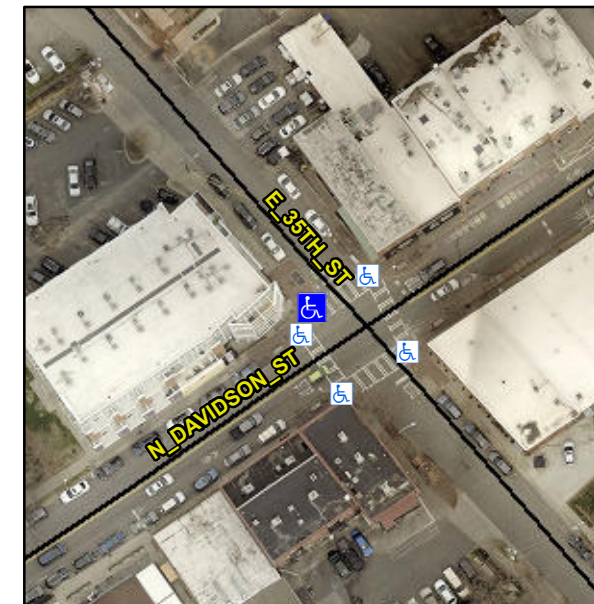
Compliance	Description	Data	Compliance	Description	Data
N/A	Ramp Length (in)	76.0	Yes	BlendTrans Slope (%)	2.5
Yes	Ramp Width (in)	48.0	Yes	BlendTrans XSlope (%)	1.6
N/A	Flare Type LT	Sloped	N/A	Flare Type RT	Sloped
No	Flare Slope LT (%)	N/A	No	Flare Slope RT (%)	N/A
N/A	Flare Traversable LT?	Yes	N/A	Flare Traversable RT?	Yes
N/A	Landing Length (in)	N/A	Yes	DWS Provided?	Yes
N/A	Landing Width (in)	N/A	Yes	DWS Contrast?	Yes
N/A	Landing Slope (%)	N/A	Yes	DWS Length (in)	24.0
N/A	Landing X Slope (%)	N/A	Yes	DWS Full Width?	Yes
N/A	Landing Curb? (Y/N)	No	Yes	DWS Offset (in)	0.0
N/A	Shared Landing?	No			
Yes	Gutter Ponding?	No	Yes	Gutter Slope (%)	2.2
No	Gutter Lip Ht (in)	0.5	Yes	Gutter X Slope (%)	0.8
N/A	Painted X Walk1?	Yes	N/A	Painted X Walk2?	N/A
	X Walk 1 Direction	To NE		X Walk 2 Direction	N/A
	X Walk 1 Width (in)	112.0		X Walk 2 Width (in)	N/A
	X Walk 1 Slope (%)	1.5		X Walk 2 Slope (%)	N/A
	X Walk 1 X Slope (%)	1.1		X Walk 2 X Slope (%)	N/A

Yes	Ramp inside XWalk1?	Yes	N/A	Ramp inside XWalk2?	N/A
	Road Slope (%)	1.1		Clear Space?	Yes
	Road X Slope (%)	1.5	N/A	Clear Space to XWalk (in)	N/A
Yes	Any Obstructions?	No	Yes	Storm Grate/Utility Hazard?	No
	Obstruction Type			Storm Grate/Utility Type	
		N/A			N/A
			Yes	Surface Condition? (G/P)	Good
			Yes	Curb Slope (%)	4.6

Remove & Replace Curb Ramp With Two New Directional Ramps or Equivalent. Grind Gutter Lip.

R304.2.3, R302.7.2
