Access Compliance Report Public Rights-of-Way (Curb Ramps)

Intersection ID: 23784 Main Street: E WESTINGHOUSE BV **Cross Street: NATIONS FORD RD** Location: SE **Overall Compliance: No** ADA ID: 379190EE0A89 Ramp Type: PerpDiag Initial Pass/Fail: Fail Severity Score: 21.25

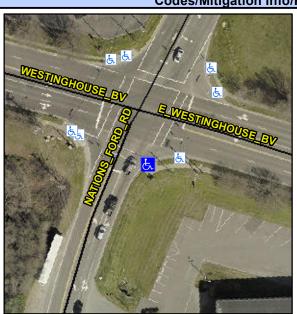
Total Cost: 3200.00 Compliance Description Data Compliance Description Data No N/A Ramp Length (in) 120.0 Ramp Slope (%) 8.6 Yes Ramp XSlope (%) No Ramp Width (in) 45.0 1.3 N/A N/A Flare Type LT N/A Flare Type RT N/A N/A N/A N/A Flare Slope RT (%) N/A Flare Slope LT (%) N/A Flare Traversable LT? N/A N/A Flare Traversable RT? N/A N/A N/A N/A **DWS Provided?** N/A Landing Length (in) N/A Landing Width (in) N/A N/A **DWS Contrast?** N/A N/A N/A N/A Landing Slope (%) DWS Length (in) N/A N/A Landing X Slope (%) N/A N/A DWS Full Width? N/A N/A Landing Curb? (Y/N) N/A N/A DWS Offset (in) N/A N/A N/A Shared Landing? N/A **Gutter Ponding?** N/A N/A Gutter Slope (%) N/A N/A Gutter Lip Ht (in) N/A N/A Gutter X Slope (%) N/A N/A Painted X Walk1? Yes N/A Painted X Walk2? Yes X Walk 1 Direction To NE X Walk 2 Direction To NW N/A 96.0 N/A 97.0 X Walk 1 Width (in) X Walk 2 Width (in) X Walk 1 Slope (%) 2.3 X Walk 2 Slope (%) 1.8 X Walk 1 X Slope (%) 1.6 X Walk 2 X Slope (%) 2.4 N/A N/A Ramp inside XWalk2? Ramp inside XWalk1? Yes Yes Road Slope (%) 1.3 N/A Clear Space? N/A N/A Road X Slope (%) 2.2 Clear Space to XWalk (in) N/A N/A N/A N/A Any Obstructions? Storm Grate/Utility Hazard? N/A **Obstruction Type** Storm Grate/Utility Type N/A N/A Yes Surface Condition? (G/P) Good

Possible Solutions: Remove & Replace Curb Ramp With Two New Directional Ramps or Equivalent. Surveyor Notes: N/A PROW/ADA: Not Found, R304.5.1, R304.2.2
