Access Compliance Report

Public Rights-of-Way

(Curb Ramps)

Intersection ID: 15786	Main Street: N_SHARON_AMITY_RD	Cross Street: AMITY_PL	Location: E
ADA ID: 379CF1328842	Ramp Type: PerpDiag	Initial Pass/Fail: Pass	Overall Compliance: No
Severity Score: 0.25			
Codes/Mitigation Info/Possible Solution		Field Measurements/Component Compliance

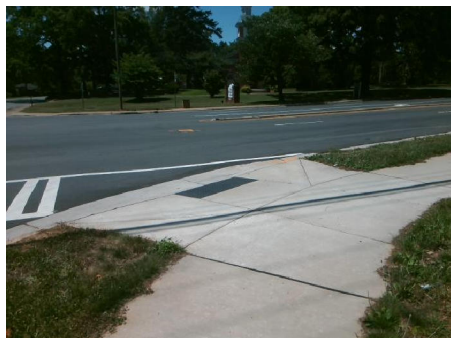
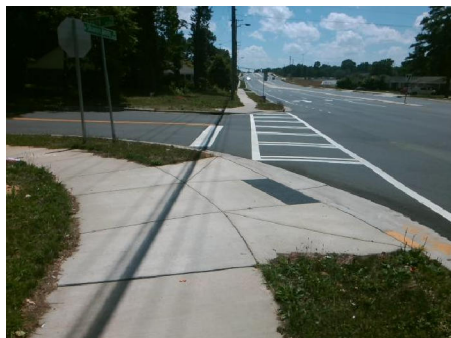
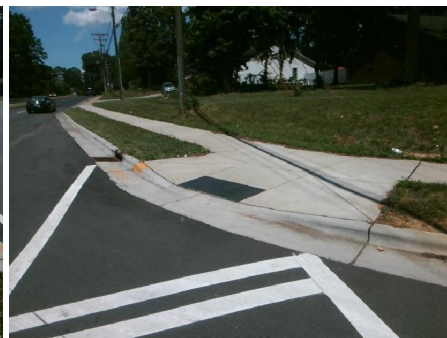
Not Found, R304.5.3

Compliance	Description	Data	Compliance	Description	Data
N/A	Ramp Length (in)	65.0	Yes	Ramp Slope (%)	7.4
Yes	Ramp Width (in)	59.0	No	Ramp XSlope (%)	2.7
N/A	Flare Type LT	Sloped	N/A	Flare Type RT	N/A
N/A	Flare Slope LT (%)	7.8	Yes	Flare Slope RT (%)	3.9
N/A	Flare Traversable LT?	Yes	N/A	Flare Traversable RT?	Yes
Yes	Landing Length (in)	70.5	Yes	DWS Provided?	Yes
Yes	Landing Width (in)	59.0	Yes	DWS Contrast?	Yes
Yes	Landing Slope (%)	1.4	Yes	DWS Length (in)	24.0
Yes	Landing X Slope (%)	1.9	Yes	DWS Full Width?	Yes
N/A	Landing Curb? (Y/N)	No	Yes	DWS Offset (in)	0.5
N/A	Shared Landing?	No			
Yes	Gutter Ponding?	No	Yes	Gutter Slope (%)	0.1
Yes	Gutter Lip Ht (in)	0.0	Yes	Gutter X Slope (%)	1.8
N/A	Painted X Walk1?	No	N/A	Painted X Walk2?	Yes
	X Walk 1 Direction	To NW		X Walk 2 Direction	To SW
N/A	X Walk 1 Width (in)	N/A	N/A	X Walk 2 Width (in)	95.0
	X Walk 1 Slope (%)	5.8		X Walk 2 Slope (%)	1.2
	X Walk 1 X Slope (%)	3.6		X Walk 2 X Slope (%)	5.1

N/A	Ramp inside XWalk1?	N/A	Yes	Ramp inside XWalk2?	Yes
	Road Slope (%)	0.7	N/A	Clear Space?	Yes
	Road X Slope (%)	5.2	N/A	Clear Space to XWalk (in)	N/A
Yes	Any Obstructions?	No	Yes	Storm Grate/Utility Hazard?	No
	Obstruction Type			Storm Grate/Utility Type	
		N/A			N/A
			Yes	Surface Condition? (G/P)	Good

Remove & Replace Curb Ramp With Two New Directional Ramps or Equivalent.
