| Intersection ID: 10021978 | Main Street: BROOKSVALE_ST | Cross Street: N/A | Location: | SW |
| ADA ID: 37A805F09F77 | Ramp Type: Perp | Initial Pass/Fail: Fail | Overall Compliance: No | Severity Score: 12.5 |

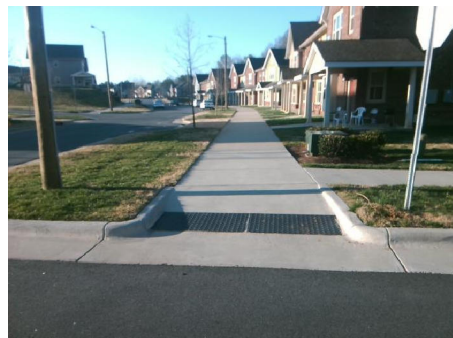
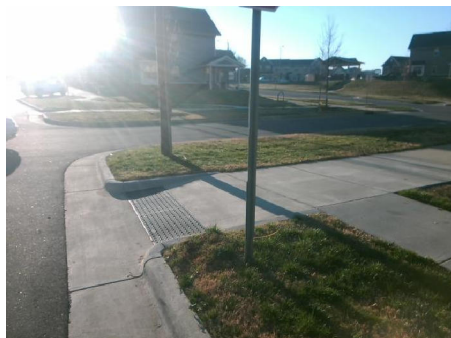
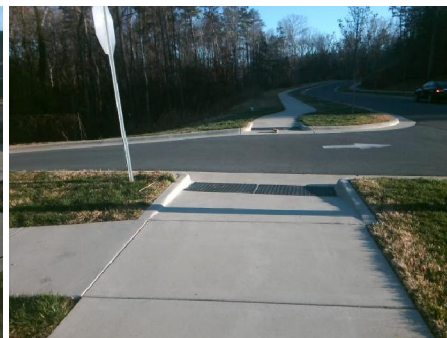
Not Found, R304.2.2

| Possible Solutions: | | | Compliance | Description | Data | Compliance | Description | Data |
|--|--|--|---|---|---|---|---|---|
| Remove & Replace Entire Ramp. | | | N/A | Ramp Length (in) | 72.0 | No | Ramp Slope (%) | 8.5 |

Remove & Replace Entire Ramp.
