## Access Compliance Report Public Rights-of-Way (Curb Ramps)

Intersection ID: 4686Main Street:EVANSHIRE\_DRCross Street:TRINITY\_RDLocation:NEADA ID: 37AA01C103E2Ramp Type:BlendTrans2Initial Pass/Fail:FailOverall Compliance:NoSeverity Score:8.75

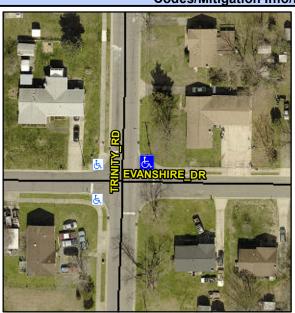
VEGETATION OVERGROWTH, NO LT SW

PROW/ADA:
Not Found, R304.5.1

Compliance Description [		Data	Compliance Description		Data
N/A	Ramp Length (in)	94.0	Yes	BlendTrans Slope (%)	3.3
No	Ramp Width (in)	40.5	Yes	BlendTrans XSlope (%)	0.9
N/A	Flare Type LT	N/A	N/A	Flare Type RT	N/A
N/A	Flare Slope LT (%)	N/A	N/A	Flare Slope RT (%)	N/A
N/A	Flare Traversable LT?	N/A	N/A	Flare Traversable RT?	N/A
N/A	Landing Length (in)	N/A	N/A	DWS Provided?	N/A
N/A	Landing Width (in)	N/A	N/A	DWS Contrast?	N/A
N/A	Landing Slope (%)	N/A	N/A	DWS Length (in)	N/A
N/A	Landing X Slope (%)	N/A	N/A	DWS Full Width?	N/A
N/A	Landing Curb? (Y/N)	N/A	N/A	DWS Offset (in)	N/A
N/A	Shared Landing?	N/A			
N/A	Gutter Ponding?	N/A	N/A	Gutter Slope (%)	N/A
N/A	Gutter Lip Ht (in)	N/A	N/A	Gutter X Slope (%)	N/A
N/A	Painted X Walk1?	No	N/A	Painted X Walk2?	N/A
	X Walk 1 Direction	To W		X Walk 2 Direction	N/A
	X Walk 1 Width (in)	N/A		X Walk 2 Width (in)	N/A
	X Walk 1 Slope (%)	2.0		X Walk 2 Slope (%)	N/A
	X Walk 1 X Slope (%)	0.5		X Walk 2 X Slope (%)	N/A

N/A	Ramp inside XWalk1?	N/A	N/A	Ramp inside XWalk2?	N/A
	Road Slope (%)	0.5		Clear Space?	N/A
	Road X Slope (%)	2.0	N/A	Clear Space to XWalk (in)	N/A
N/A	Any Obstructions?	N/A	N/A	Storm Grate/Utility Hazard?	N/A
	Obstruction Type		l	Storm Grate/Utility Type	
		N/A	l		N/A
			Yes	Surface Condition? (G/P)	Good
THE	L Company		No	Curb Slope (%)	8.6

Remove & Replace Curb Ramp With Two New Directional Ramps or Equivalent.
