## **Access Compliance Report Public Rights-of-Way** (Curb Ramps)

Main Street: S\_TURNER\_AV Intersection ID: 10710 **Cross Street: STATE\_ST** Location:

ADA ID: 37B2FB6B83C0 **Overall Compliance: No** Ramp Type: Directional1 Initial Pass/Fail: Fail Severity Score: 33.75

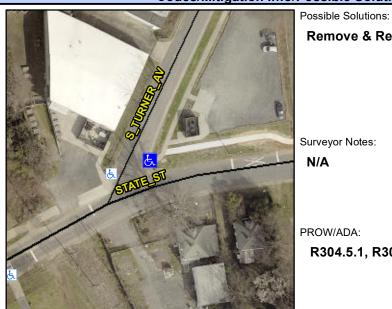
Field Measurements/Component Compliance							
Compliance Description		Data	Compliance Description		Data		
N/A	Ramp Length (in)	85.0	N/A	Grade Break?	N/A		
No	Ramp Width (in)	44.5	N/A	Grade Break Slope (%)	0.0		
No	Ramp Slope (%)	12.1	N/A	Grade Break XSlope (%)	0.0		
Yes	Ramp XSlope (%)	1.1					
N/A	Flare Type LT	N/A	N/A	Flare Type RT	N/A		
N/A	Flare Slope LT (%)	N/A	N/A	Flare Slope RT (%)	0.0		
N/A	Flare Traversable LT?	N/A	N/A	Flare Traversable RT?	N/A		
N/A	Landing Length (in)	0.0	N/A	DWS Provided?	N/A		
N/A	Landing Width (in)	0.0	N/A	DWS Contrast?	N/A		
N/A	Landing Slope (%)	0.0	N/A	DWS Length (in)	N/A		
N/A	Landing X Slope (%)	0.0	N/A	DWS Full Width?	N/A		
N/A	Landing Curb? (Y/N)	N/A	N/A	DWS Offset LT (in)	N/A		
N/A	Shared Landing?	N/A	N/A	DWS Offset RT (in)	N/A		
N/A	Gutter Ponding?	0.0	N/A	Gutter Slope (%)	N/A		
N/A	Gutter Lip Ht (in)	0.0	N/A	Gutter X Slope (%)	N/A		
N/A	Painted X Walk1?	No		Road Slope (%)	0.0

X Walk 1 Direction	To SW		Road X Slope (%)	4.8		
	X Walk 1 Width (in)	N/A		Clear Space?	N/A		
	X Walk 1 Slope (%)	0.0	N/A	Clear Space to XWalk (in)	N/A		
	X Walk 1 X Slope (%)	4.8	N/A	Storm Grate/Utility Hazard?	N/A		
N/A	Ramp inside XWalk1?	N/A		Storm Grate/Utility Type			
N/A	Any Obstructions?	N/A			N/A		
	Obstruction Type		Yes	Surface Condition? (G/P)	Good		
		N/A	N/A	Curb Slope (%)	6.8

1 COOLDIC COLUMNIO.	
Remove & Replace Entire Ramp.	N
•	N
	N
	Υ
	N
	N
Surveyor Notes:	N
N/A	N
	N
	N
	N
PROW/ADA:	N
R304.5.1, R304.2.2	N
·	N
	N
	N
