# Access Compliance Report

## Public Rights-of-Way (Curb Ramps)

| Intersection ID: 22536 | Main Street: PROVIDENCE_RD | Cross Street: SUMMER_TREE_LN | Location: NE |
| ADA ID: 37BC3E4009C2 | Ramp Type: Perp | Initial Pass/Fail: Fail | Overall Compliance: No |

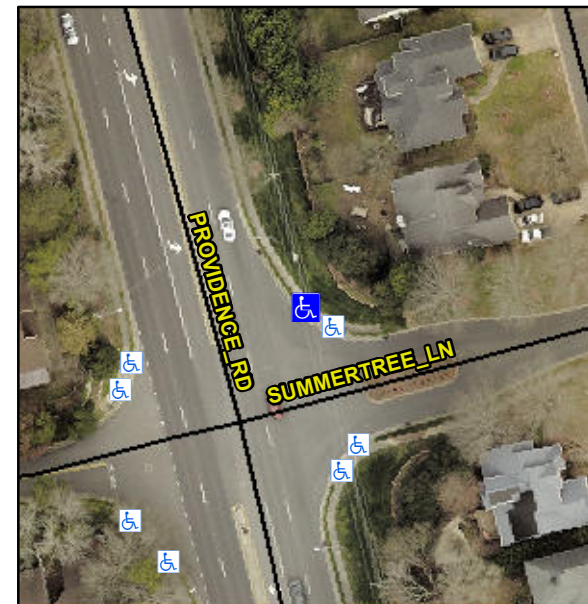
**R304.5.1, R304.2.2, R304.5.3**

| Compliance | Description | Data | Compliance | Description | Data |
|---|---|---|---|---|---|
| N/A | Ramp Length (in) | <b>62.0</b> | No | Ramp Slope (%) | <b>12.0</b> |
| No | Ramp Width (in) | <b>46.0</b> | No | Ramp XSlope (%) | <b>7.2</b> |

**Remove & Replace Entire Ramp.**

Total Cost: \$ **1850.00**
