Access Compliance Report Public Rights-of-Way (Curb Ramps)

Intersection ID: 10032566Main Street:N_GRAHAM_STCross Street:N/ALocation:WADA ID: 37CC2895A05BRamp Type:ParaInitial Pass/Fail:PassOverall Compliance:NoSeverity Score:0

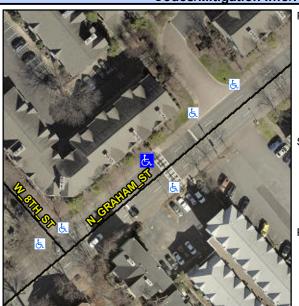
Compliance Description Data		Compliance Description		Data	
N/A	Ramp Length LT (in)	48.0	N/A	Ramp Length RT (in)	60.0
Yes	Ramp Width LT (in)	69.0	Yes	Ramp Width RT (in)	68.0
Yes	Ramp Slope LT (%)	5.5	Yes	Ramp Slope RT (%)	5.8
Yes	Ramp XSlope LT (%)	0.2	Yes	Ramp XSlope RT (%)	2.0
Yes	Landing Length (in)	69.0	Yes	DWS Provided?	Yes
Yes	Landing Width (in)	72.0	Yes	DWS Contrast?	Yes
Yes	Landing Slope (%)	1.4	Yes	DWS Length (in)	24.0
No	Landing X Slope (%)	2.1	Yes	DWS Full Width?	Yes
N/A	Landing Curb? (Y/N)	Yes	Yes	DWS Offset (in)	0.0
N/A	Shared Landing?	No			
Yes	Gutter Ponding?	No	Yes	Gutter Slope (%)	1.7
Yes	Gutter Lip Ht (in)	0.0	No	Gutter X Slope (%)	2.3
N/A	Painted X Walk1?	Yes	N/A	Painted X Walk2?	N/A
	X Walk 1 Direction	To SE		X Walk 2 Direction	N/A
N/A	X Walk 1 Width (in)	109.0	N/A	X Walk 2 Width (in)	N/A
	X Walk 1 Slope (%)	2.7		X Walk 2 Slope (%)	N/A
	X Walk 1 X Slope (%)	1.8		X Walk 2 X Slope (%)	N/A

Yes	Ramp inside XWalk1?	Yes	N/A	Ramp inside XWalk2?	N/A
	Road Slope (%)	N/A	N/A	Clear Space?	Yes
	Road X Slope (%)	N/A	N/A	Clear Space to XWalk (in)	N/A
Yes	Any Obstructions?	No	Yes	Storm Grate/Utility Hazard?	No
	Obstruction Type			Storm Grate/Utility Type	
		N/A			N/A
			Yes	Surface Condition? (G/P)	Good
			Compliatմurb Slope (%)		1.5

Total Cost: \$ 1250.00
