# Access Compliance Report

## Public Rights-of-Way

### (Curb Ramps)

Intersection ID: 20314	Main Street: COLONY_RD	Cross Street: MORROCROFT_FARMS_LN	Location: S
ADA ID: 37D01FA98238	Ramp Type: Directional1	Initial Pass/Fail: Fail	Overall Compliance: No
		Severity Score: 1.25

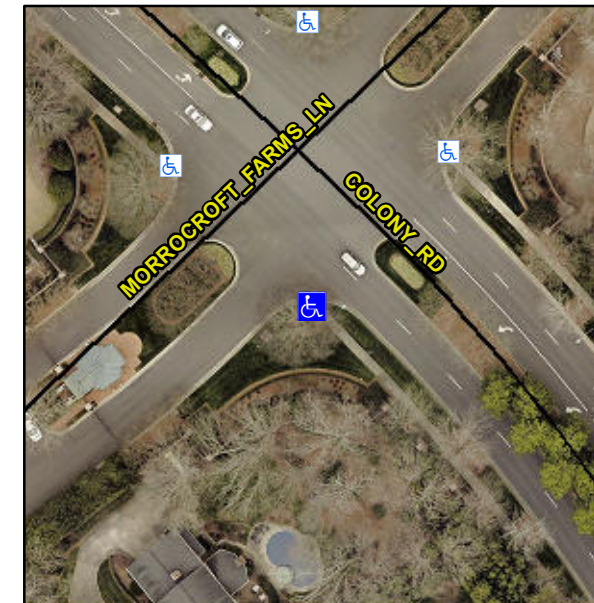
Compliance	Description	Data	Compliance	Description	Data
N/A	Ramp Length (in)	65.0	N/A	Grade Break?	N/A
Yes	Ramp Width (in)	58.0	N/A	Grade Break Slope (%)	0.0
Yes	Ramp Slope (%)	5.4	N/A	Grade Break XSlope (%)	0.0
No	Ramp XSlope (%)	2.9			
N/A	Flare Type LT	N/A	N/A	Flare Type RT	N/A
N/A	Flare Slope LT (%)	N/A	N/A	Flare Slope RT (%)	0.0
N/A	Flare Traversable LT?	N/A	N/A	Flare Traversable RT?	N/A
N/A	Landing Length (in)	0.0	N/A	DWS Provided?	N/A
N/A	Landing Width (in)	0.0	N/A	DWS Contrast?	N/A
N/A	Landing Slope (%)	0.0	N/A	DWS Length (in)	N/A
N/A	Landing X Slope (%)	0.0	N/A	DWS Full Width?	N/A
N/A	Landing Curb? (Y/N)	N/A	N/A	DWS Offset LT (in)	N/A
N/A	Shared Landing?	N/A	N/A	DWS Offset RT (in)	N/A
N/A	Gutter Ponding?	0.0	N/A	Gutter Slope (%)	N/A
N/A	Gutter Lip Ht (in)	0.0	N/A	Gutter X Slope (%)	N/A
N/A	Painted X Walk1?	No		Road Slope (%)	2.4
	X Walk 1 Direction	To NW		Road X Slope (%)	0.9
	X Walk 1 Width (in)	N/A		Clear Space?	N/A

X Walk 1 Slope (%)	2.4	N/A	Clear Space to XWalk (in)	N/A
	X Walk 1 X Slope (%)	0.9	N/A	Storm Grate/Utility Hazard?	N/A
N/A	Ramp inside XWalk1?	N/A		Storm Grate/Utility Type	
N/A	Any Obstructions?	N/A			N/A
	Obstruction Type		Yes	Surface Condition? (G/P)	Good
			N/A	Curb Slope (%)	20.3

Possible Solutions:

**Remove & Replace Entire Ramp.**

PROW/ADA:

**R304.5.3**

Total Cost:

\$ 1600.00
