# Access Compliance Report

## Public Rights-of-Way

| Intersection ID: 27906 | Main Street: BALLANTYNE_COUNTRY_CLUB_DR | Cross Street: HARRISON'S_CROSSING_AV | Location: SE |
| ADA ID: 37D0BF920E93 | Ramp Type: BlendTrans2 | Initial Pass/Fail: Fail | Overall Compliance: No |

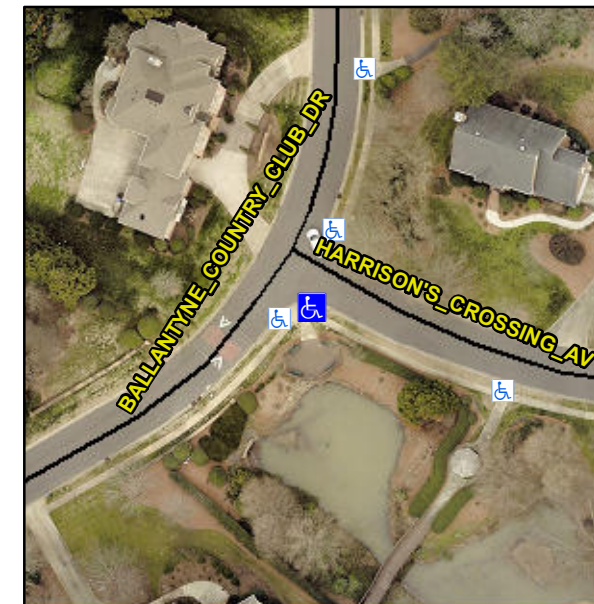
| Severity Score: 18.75 | | | |

| Compliance | Description | Data | Compliance | Description | Data |
| No | Ramp Width (in) | 35.0 | No | BlendTrans XSlope (%) | 2.2 |

**Remove & Replace Curb Ramp With Two New Directional Ramps or Equivalent.**

**R304.5.1, R304.5.3**

Total Cost: \$ 3200.00
