Access Compliance Report

Public Rights-of-Way

(Curb Ramps)

Intersection ID: 6029	Main Street: PIMPERNEL_RD	Cross Street: ROSEMALLOW_RD	Location: NW
ADA ID: 37D359392FCB	Ramp Type: Perp	Initial Pass/Fail: Fail	Overall Compliance: No
Severity Score: 25			
Codes/Mitigation Info/Possible Solution		Field Measurements/Component Compliance

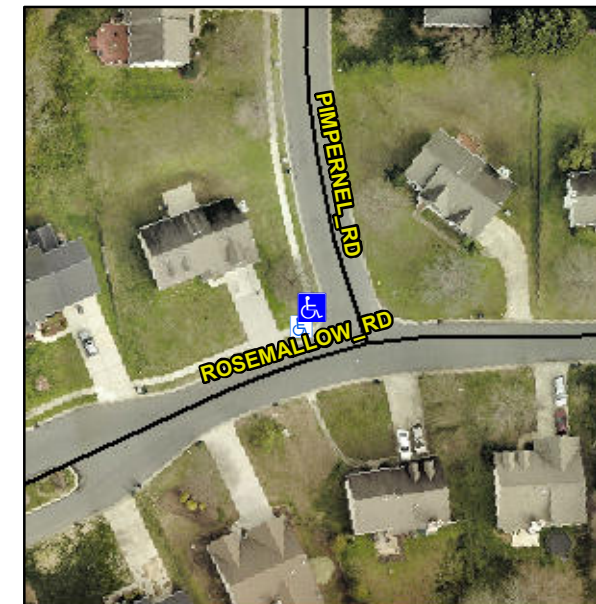
Not Found, R304.5.3

Compliance	Description	Data	Compliance	Description	Data
N/A	Ramp Length (in)	45.5	Yes	Ramp Slope (%)	5.2
Yes	Ramp Width (in)	48.0	No	Ramp XSlope (%)	8.2
N/A	Flare Type LT	N/A	N/A	Flare Type RT	N/A
N/A	Flare Slope LT (%)	N/A	N/A	Flare Slope RT (%)	N/A
N/A	Flare Traversable LT?	N/A	N/A	Flare Traversable RT?	N/A
N/A	Landing Length (in)	N/A	N/A	DWS Provided?	N/A
N/A	Landing Width (in)	N/A	N/A	DWS Contrast?	N/A
N/A	Landing Slope (%)	N/A	N/A	DWS Length (in)	N/A
N/A	Landing X Slope (%)	N/A	N/A	DWS Full Width?	N/A
N/A	Landing Curb? (Y/N)	N/A	N/A	DWS Offset (in)	N/A
N/A	Shared Landing?	N/A			
N/A	Gutter Ponding?	N/A	N/A	Gutter Slope (%)	N/A
N/A	Gutter Lip Ht (in)	1.0	N/A	Gutter X Slope (%)	N/A
N/A	Painted X Walk1?	No	N/A	Painted X Walk2?	N/A
	X Walk 1 Direction	To E		X Walk 2 Direction	N/A
N/A	X Walk 1 Width (in)	N/A	N/A	X Walk 2 Width (in)	N/A
	X Walk 1 Slope (%)	9.7		X Walk 2 Slope (%)	N/A
	X Walk 1 X Slope (%)	5.2		X Walk 2 X Slope (%)	N/A

N/A	Ramp inside XWalk1?	N/A	N/A	Ramp inside XWalk2?	N/A
	Road Slope (%)	N/A	N/A	Clear Space?	N/A
	Road X Slope (%)	N/A	N/A	Clear Space to XWalk (in)	N/A
N/A	Any Obstructions?	N/A	N/A	Storm Grate/Utility Hazard?	N/A
	Obstruction Type			Storm Grate/Utility Type	
		N/A			N/A
			Yes	Surface Condition? (G/P)	Good

Possible Solutions:

Remove & Replace Entire Ramp.
