## Access Compliance Report Public Rights-of-Way (Curb Ramps)

Intersection ID: 12435 Main Street: ALLEN\_ST Cross Street: PEGRAM\_ST Location: N

ADA ID: 37D780FCB48C Ramp Type: BlendTrans1 Initial Pass/Fail: Fail Overall Compliance: No Severity Score: 36.25

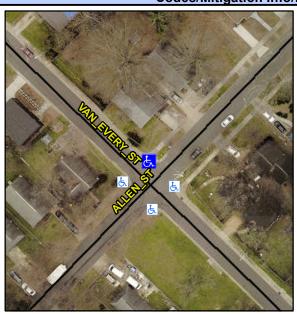
Not Found, R304.5.1, R304.5.3

Field Measurements/Component Compnance						
Compl	Compliance Description		Compliance Description		Data	
N/A	Ramp Length (in)	63.5	Yes	BlendTrans Slope (%)	4.3	
No	Ramp Width (in)	29.0	No	BlendTrans XSlope (%)	2.6	
N/A	Flare Type LT	N/A	N/A	Flare Type RT	N/A	
N/A	Flare Slope LT (%)	N/A	N/A	Flare Slope RT (%)	N/A	
N/A	Flare Traversable LT?	N/A	N/A	Flare Traversable RT?	N/A	
N/A	Landing Length (in)	N/A	N/A	DWS Provided?	N/A	
N/A	Landing Width (in)	N/A	N/A	DWS Contrast?	N/A	
N/A	Landing Slope (%)	N/A	N/A	DWS Length (in)	N/A	
N/A	Landing X Slope (%)	N/A	N/A	DWS Full Width?	N/A	
N/A	Landing Curb? (Y/N)	N/A	N/A	DWS Offset (in)	N/A	
N/A	Shared Landing?	N/A				
N/A	Gutter Ponding?	N/A	N/A	Gutter Slope (%)	N/A	
N/A	Gutter Lip Ht (in)	N/A	N/A	Gutter X Slope (%)	N/A	
N/A	Painted X Walk1?	No	N/A	Painted X Walk2?	No	
	X Walk 1 Direction	To SW		X Walk 2 Direction	To SE	
	X Walk 1 Width (in)	N/A		X Walk 2 Width (in)	N/A

X Walk 1 Slope (%)	2.8		X Walk 2 Slope (%)	0.1	
	X Walk 1 X Slope (%)	1.5		X Walk 2 X Slope (%)	2.9	
N/A	Ramp inside XWalk1?	N/A	N/A	Ramp inside XWalk2?	N/A	
	Road Slope (%)	2.8		Clear Space?	N/A	
	Road X Slope (%)	1.9	N/A	Clear Space to XWalk (in)	N/A	
N/A	Any Obstructions?	N/A	N/A	Storm Grate/Utility Hazard?	N/A	
	Obstruction Type			Storm Grate/Utility Type		
		N/A			N/A	
			Yes	Surface Condition? (G/P)	Good

VAN EVERY ST StopSign ALLEN ST None Possible Solutions:

Remove & Replace Curb Ramp With Two New Directional Ramps or Equivalent.

Total Cost: \$ 3200.00
