Intersection ID: 29698	Main Street: SIMFIELD_CHURCH_RD	Cross Street: WOODCROFT_WY	Location:	NW
ADA ID: 37E558387141	Ramp Type: PerpDiag	Initial Pass/Fail: Fail	Overall Compliance: No	Severity Score: 12.5

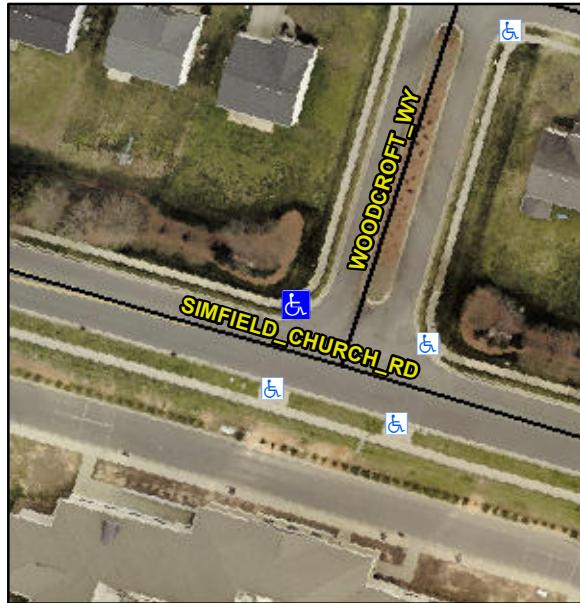
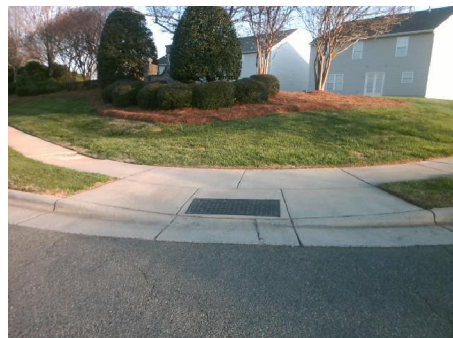
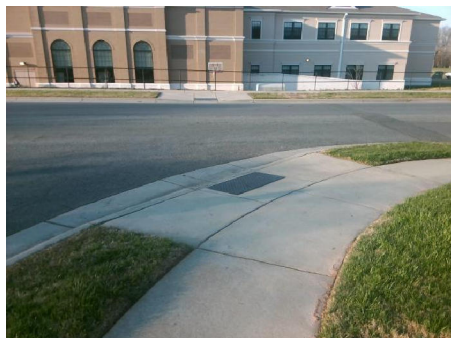
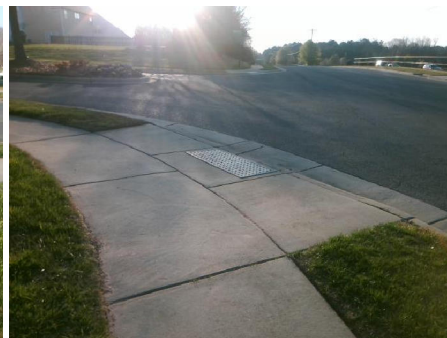
Compliance	Description	Data	Compliance	Description	Data
N/A	Ramp Length (in)	46.0	Yes	Ramp Slope (%)	5.5
Yes	Ramp Width (in)	51.0	No	Ramp XSlope (%)	6.1
N/A	Flare Type LT	N/A	N/A	Flare Type RT	N/A
N/A	Flare Slope LT (%)	N/A	N/A	Flare Slope RT (%)	N/A
N/A	Flare Traversable LT?	N/A	N/A	Flare Traversable RT?	N/A
N/A	Landing Length (in)	N/A	N/A	DWS Provided?	N/A
N/A	Landing Width (in)	N/A	N/A	DWS Contrast?	N/A
N/A	Landing Slope (%)	N/A	N/A	DWS Length (in)	N/A
N/A	Landing X Slope (%)	N/A	N/A	DWS Full Width?	N/A
N/A	Landing Curb? (Y/N)	N/A	N/A	DWS Offset (in)	N/A
N/A	Shared Landing?	N/A			
N/A	Gutter Ponding?	N/A	N/A	Gutter Slope (%)	N/A
N/A	Gutter Lip Ht (in)	N/A	N/A	Gutter X Slope (%)	N/A
N/A	Painted X Walk1?	No	N/A	Painted X Walk2?	No
	X Walk 1 Direction	To S		X Walk 2 Direction	To E
N/A	X Walk 1 Width (in)	N/A	N/A	X Walk 2 Width (in)	N/A
	X Walk 1 Slope (%)	5.0		X Walk 2 Slope (%)	0.7
	X Walk 1 X Slope (%)	0.6		X Walk 2 X Slope (%)	3.1

N/A	Ramp inside XWalk1?	N/A	N/A	Ramp inside XWalk2?	N/A
	Road Slope (%)	3.1	N/A	Clear Space?	N/A
	Road X Slope (%)	0.5	N/A	Clear Space to XWalk (in)	N/A
N/A	Any Obstructions?	N/A	N/A	Storm Grate/Utility Hazard?	N/A
	Obstruction Type			Storm Grate/Utility Type	
		N/A			N/A
			Yes	Surface Condition? (G/P)	Good

Remove & Replace Curb Ramp With Two New Directional Ramps or Equivalent.

R304.5.3
