Access Compliance Report Public Rights-of-Way (Curb Ramps)

Intersection ID: 25775Main Street: CARMEL_RDCross Street: PINEVILLE-MATTHEWS_RDLocation:NEADA ID: 37F26DB382ECRamp Type: PerpInitial Pass/Fail: FailOverall Compliance: NoSeverity Score: 21.25

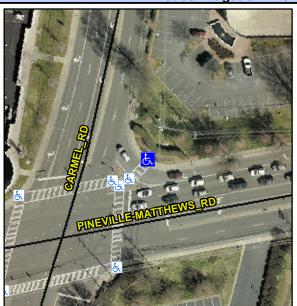
Field Measurements/Component Compliance							
Compliance Description Data		Comp	liance Description	Data			
N/A	Ramp Length (in)	59.0	No	Ramp Slope (%)	11.5		
No	Ramp Width (in)	36.0	Yes	Ramp XSlope (%)	0.7		
N/A	Flare Type LT	N/A	N/A	Flare Type RT	N/A		
N/A	Flare Slope LT (%)	N/A	N/A	Flare Slope RT (%)	N/A		
N/A	Flare Traversable LT?	N/A	N/A	Flare Traversable RT?	N/A		
N/A	Landing Length (in)	N/A	N/A	DWS Provided?	N/A		
N/A	Landing Width (in)	N/A	N/A	DWS Contrast?	N/A		
N/A	Landing Slope (%)	N/A	N/A	DWS Length (in)	N/A		
N/A	Landing X Slope (%)	N/A	N/A	DWS Full Width?	N/A		
N/A	Landing Curb? (Y/N)	N/A	N/A	DWS Offset (in)	N/A		
N/A	Shared Landing?	N/A					
N/A	Gutter Ponding?	N/A	N/A	Gutter Slope (%)	N/A		
N/A	Gutter Lip Ht (in)	N/A	N/A	Gutter X Slope (%)	N/A		
N/A	Painted X Walk1?	Yes	N/A	Painted X Walk2?	N/A		
	X Walk 1 Direction	To SW		X Walk 2 Direction	N/A		
N/A	X Walk 1 Width (in)	124.0	N/A	X Walk 2 Width (in)	N/A

X Walk 1 Slope (%)	1.6		X Walk 2 Slope (%)	N/A		
	X Walk 1 X Slope (%)	1.3		X Walk 2 X Slope (%)	N/A		
N/A	Ramp inside XWalk1?	Yes	N/A	Ramp inside XWalk2?	N/A		
	Road Slope (%)	N/A	N/A	Clear Space?	N/A		
	Road X Slope (%)	N/A	N/A	Clear Space to XWalk (in)	N/A		
N/A	Any Obstructions?	N/A	N/A	Storm Grate/Utility Hazard?	N/A		
	Obstruction Type			Storm Grate/Utility Type			
		N/A			N/A		
			Yes	Surface Condition? (G/P)	Good

Possible Solutions:	14					
Remove & Replace Entire Ramp.						
	I					
Surveyor Notes:						
N/A						
PDOW/ADA						
PROW/ADA:						
Not Found, R304.5.1, R304.2.2
