Access Compliance Report

Public Rights-of-Way

(Curb Ramps)

Intersection ID: 13071	Main Street: N_SHARON_AMITY_RD	Cross Street: VERNEDALE_RD	Location: E
ADA ID: 37FA82C4F550	Ramp Type: Perp	Initial Pass/Fail: Fail	Overall Compliance: No
Severity Score: 21.25			
Codes/Mitigation Info/Possible Solution		Field Measurements/Component Compliance

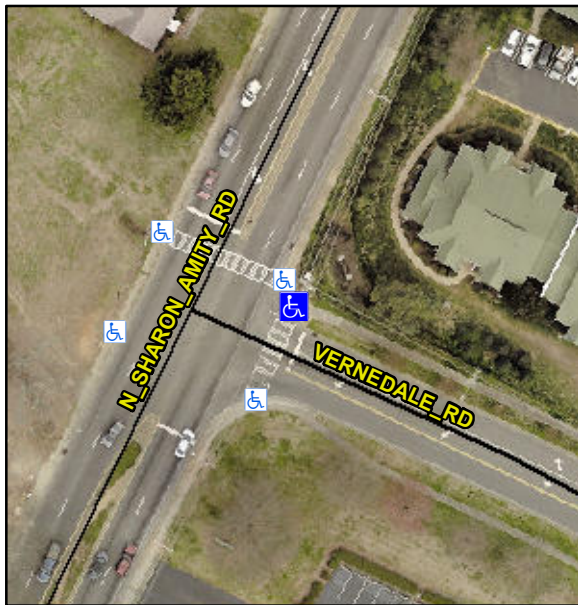
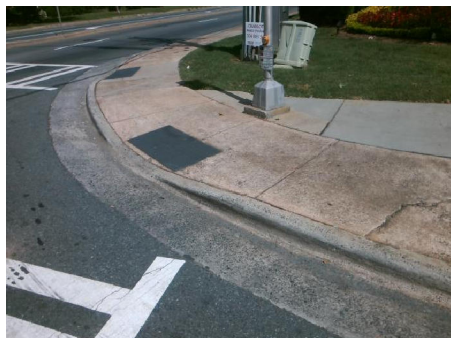
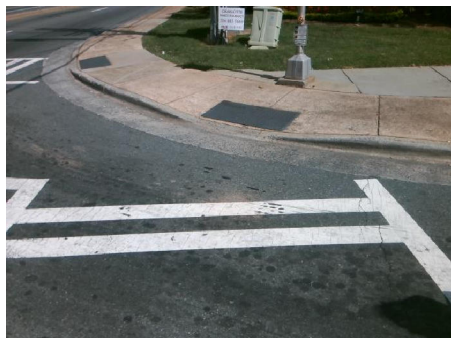
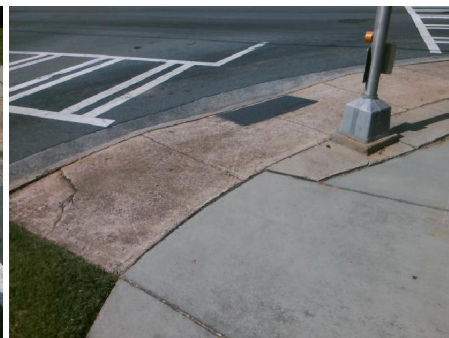
Not Found, R304.5.1, R304.2.2

Compliance	Description	Data	Compliance	Description	Data
N/A	Ramp Length (in)	65.0	No	Ramp Slope (%)	8.4
No	Ramp Width (in)	39.0	Yes	Ramp XSlope (%)	1.9
N/A	Flare Type LT	N/A	N/A	Flare Type RT	N/A
N/A	Flare Slope LT (%)	N/A	N/A	Flare Slope RT (%)	N/A
N/A	Flare Traversable LT?	N/A	N/A	Flare Traversable RT?	N/A
N/A	Landing Length (in)	N/A	N/A	DWS Provided?	N/A
N/A	Landing Width (in)	N/A	N/A	DWS Contrast?	N/A
N/A	Landing Slope (%)	N/A	N/A	DWS Length (in)	N/A
N/A	Landing X Slope (%)	N/A	N/A	DWS Full Width?	N/A
N/A	Landing Curb? (Y/N)	N/A	N/A	DWS Offset (in)	N/A
N/A	Shared Landing?	N/A			
N/A	Gutter Ponding?	N/A	N/A	Gutter Slope (%)	N/A
N/A	Gutter Lip Ht (in)	N/A	N/A	Gutter X Slope (%)	N/A
N/A	Painted X Walk1?	Yes	N/A	Painted X Walk2?	N/A
	X Walk 1 Direction	To SW		X Walk 2 Direction	N/A
N/A	X Walk 1 Width (in)	112.0	N/A	X Walk 2 Width (in)	N/A
	X Walk 1 Slope (%)	1.9		X Walk 2 Slope (%)	N/A
	X Walk 1 X Slope (%)	2.7		X Walk 2 X Slope (%)	N/A

N/A	Ramp inside XWalk1?	Yes	N/A	Ramp inside XWalk2?	N/A
	Road Slope (%)	N/A	N/A	Clear Space?	N/A
	Road X Slope (%)	N/A	N/A	Clear Space to XWalk (in)	N/A
N/A	Any Obstructions?	N/A	N/A	Storm Grate/Utility Hazard?	N/A
	Obstruction Type			Storm Grate/Utility Type	
		N/A			N/A
			Yes	Surface Condition? (G/P)	Good

Remove & Replace Entire Ramp.
