Access Compliance Report

Public Rights-of-Way

(Curb Ramps)

Intersection ID: 12365	Main Street: E_10TH_ST	Cross Street: N_ALEXANDER_ST	Location: W
ADA ID: 37FDDED512A3	Ramp Type: PerpDiag	Initial Pass/Fail: Fail	Overall Compliance: No
Severity Score: 22.5			
Codes/Mitigation Info/Possible Solution		Field Measurements/Component Compliance

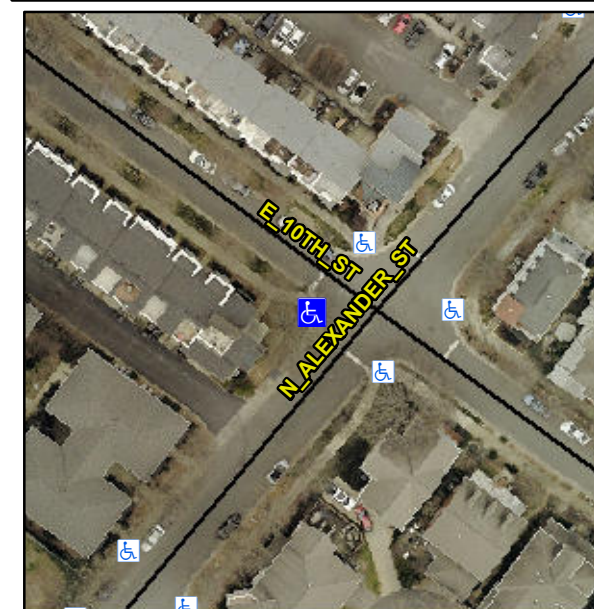
Not Found, R304.5.1, R304.2.2, R304.5.3

Compliance	Description	Data	Compliance	Description	Data
N/A	Ramp Length (in)	27.0	No	Ramp Slope (%)	9.4
No	Ramp Width (in)	46.0	No	Ramp XSlope (%)	3.3
N/A	Flare Type LT	N/A	N/A	Flare Type RT	N/A
N/A	Flare Slope LT (%)	N/A	N/A	Flare Slope RT (%)	N/A
N/A	Flare Traversable LT?	N/A	N/A	Flare Traversable RT?	N/A
N/A	Landing Length (in)	N/A	N/A	DWS Provided?	N/A
N/A	Landing Width (in)	N/A	N/A	DWS Contrast?	N/A
N/A	Landing Slope (%)	N/A	N/A	DWS Length (in)	N/A
N/A	Landing X Slope (%)	N/A	N/A	DWS Full Width?	N/A
N/A	Landing Curb? (Y/N)	N/A	N/A	DWS Offset (in)	N/A
N/A	Shared Landing?	N/A			
N/A	Gutter Ponding?	N/A	N/A	Gutter Slope (%)	N/A
N/A	Gutter Lip Ht (in)	N/A	N/A	Gutter X Slope (%)	N/A
N/A	Painted X Walk1?	No	N/A	Painted X Walk2?	No
	X Walk 1 Direction	To SE		X Walk 2 Direction	To NE
N/A	X Walk 1 Width (in)	N/A	N/A	X Walk 2 Width (in)	N/A
	X Walk 1 Slope (%)	4.1		X Walk 2 Slope (%)	2.9
	X Walk 1 X Slope (%)	0.0		X Walk 2 X Slope (%)	5.1

N/A	Ramp inside XWalk1?	N/A	N/A	Ramp inside XWalk2?	N/A
	Road Slope (%)	3.3	N/A	Clear Space?	N/A
	Road X Slope (%)	3.6	N/A	Clear Space to XWalk (in)	N/A
N/A	Any Obstructions?	N/A	N/A	Storm Grate/Utility Hazard?	N/A
	Obstruction Type			Storm Grate/Utility Type	
		N/A			N/A
		Yes		Surface Condition? (G/P)	Good

Remove & Replace Curb Ramp With Two New Directional Ramps or Equivalent.
