# Access Compliance Report

## Public Rights-of-Way

### (Curb Ramps)

Intersection ID: 6113	Main Street: PURSLANE_CT	Cross Street: YARROW_RD	Location: W
ADA ID: 38037A8CA5F3	Ramp Type: Perp	Initial Pass/Fail: Fail	Overall Compliance: No
			Severity Score: 36.25

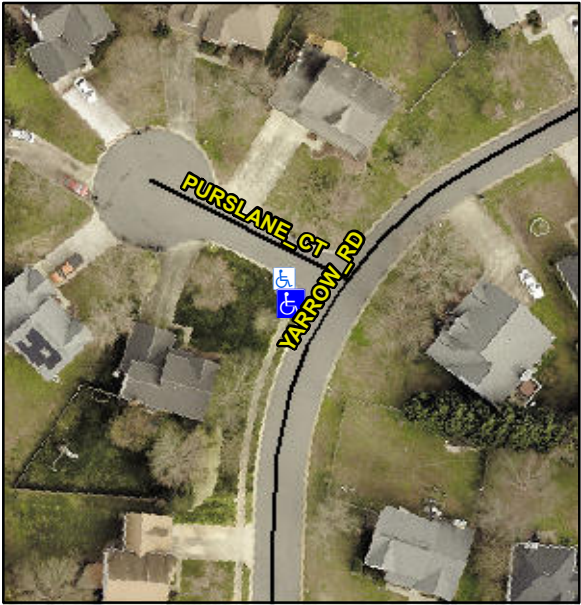
Possible Solutions:		<b>Compliance</b>	<b>Description</b>	<b>Data</b>
	<b>Remove &amp; Replace Entire Ramp.</b>		<b>Yes</b>	Ramp Length (in)	7.4
			<b>No</b>	Ramp Width (in)	2.9
			<b>N/A</b>	Flare Type LT	N/A
			<b>N/A</b>	Flare Slope LT (%)	N/A
			<b>N/A</b>	Flare Traversable LT?	N/A
			<b>N/A</b>	Landing Length (in)	N/A
			<b>N/A</b>	Landing Width (in)	N/A
			<b>N/A</b>	Landing Slope (%)	N/A
			<b>N/A</b>	Landing X Slope (%)	N/A
<p>Surveyor Notes:</p> <p><b>N/A</b></p> <p>PROW/ADA:</p> <p><b>Not Found, R304.5.1</b></p>			<b>N/A</b>	Flare Type RT	N/A
			<b>N/A</b>	Flare Slope RT (%)	N/A
			<b>N/A</b>	Flare Traversable RT?	N/A
			<b>N/A</b>	DWS Provided?	N/A
			<b>N/A</b>	DWS Contrast?	N/A
			<b>N/A</b>	DWS Length (in)	N/A
			<b>N/A</b>	DWS Full Width?	N/A
			<b>N/A</b>	DWS Offset (in)	N/A
			<b>N/A</b>	Shared Landing?	N/A

<b>N/A</b>	Gutter Ponding?	N/A
			<b>N/A</b>	Gutter Lip Ht (in)	N/A
			<b>No</b>	Painted X Walk1?	N/A
				X Walk 1 Direction	N/A
			<b>N/A</b>	X Walk 1 Width (in)	N/A
			<b>1.6</b>	X Walk 1 Slope (%)	N/A
			<b>3.5</b>	X Walk 1 X Slope (%)	N/A
			<b>N/A</b>	Ramp inside XWalk1?	N/A
			<b>N/A</b>	Road Slope (%)	N/A
			<b>N/A</b>	Road X Slope (%)	N/A
			<b>N/A</b>	Any Obstructions?	N/A
				Obstruction Type	N/A
			<b>N/A</b>		N/A
			<b>Yes</b>	Surface Condition? (G/P)	Good

Total Cost: \$ 1850.00
